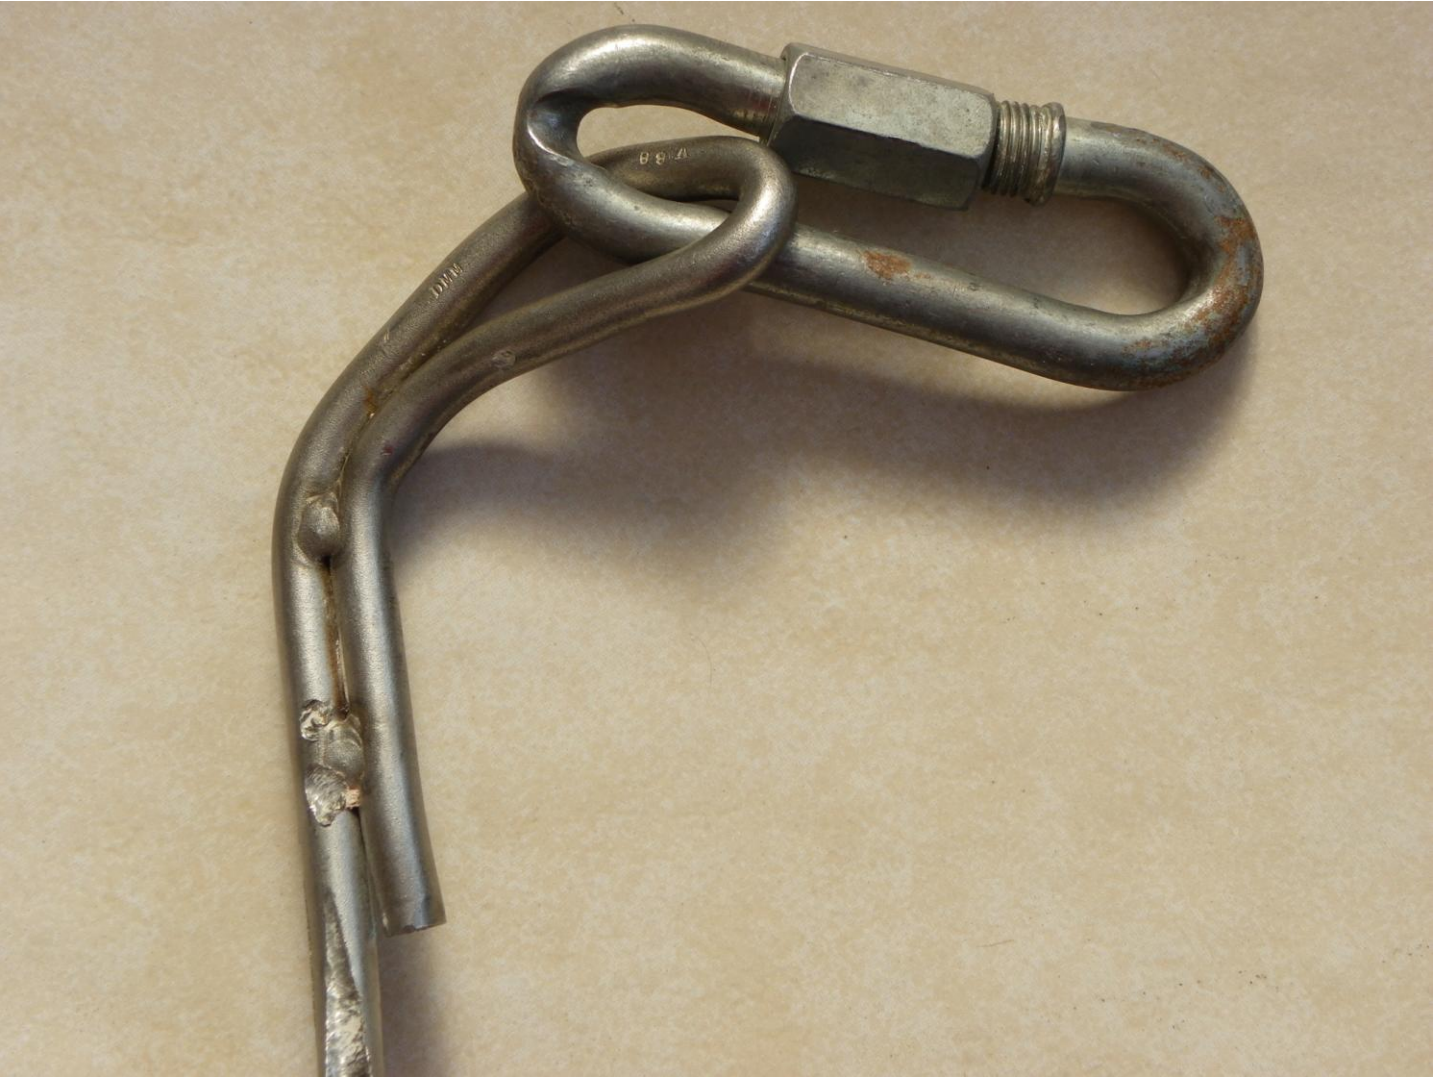
Maillon used during a radial test to destruction. The maillon deformed after as we undone the screw thread. Note the movement of metal from the contact area with the Eco anchor

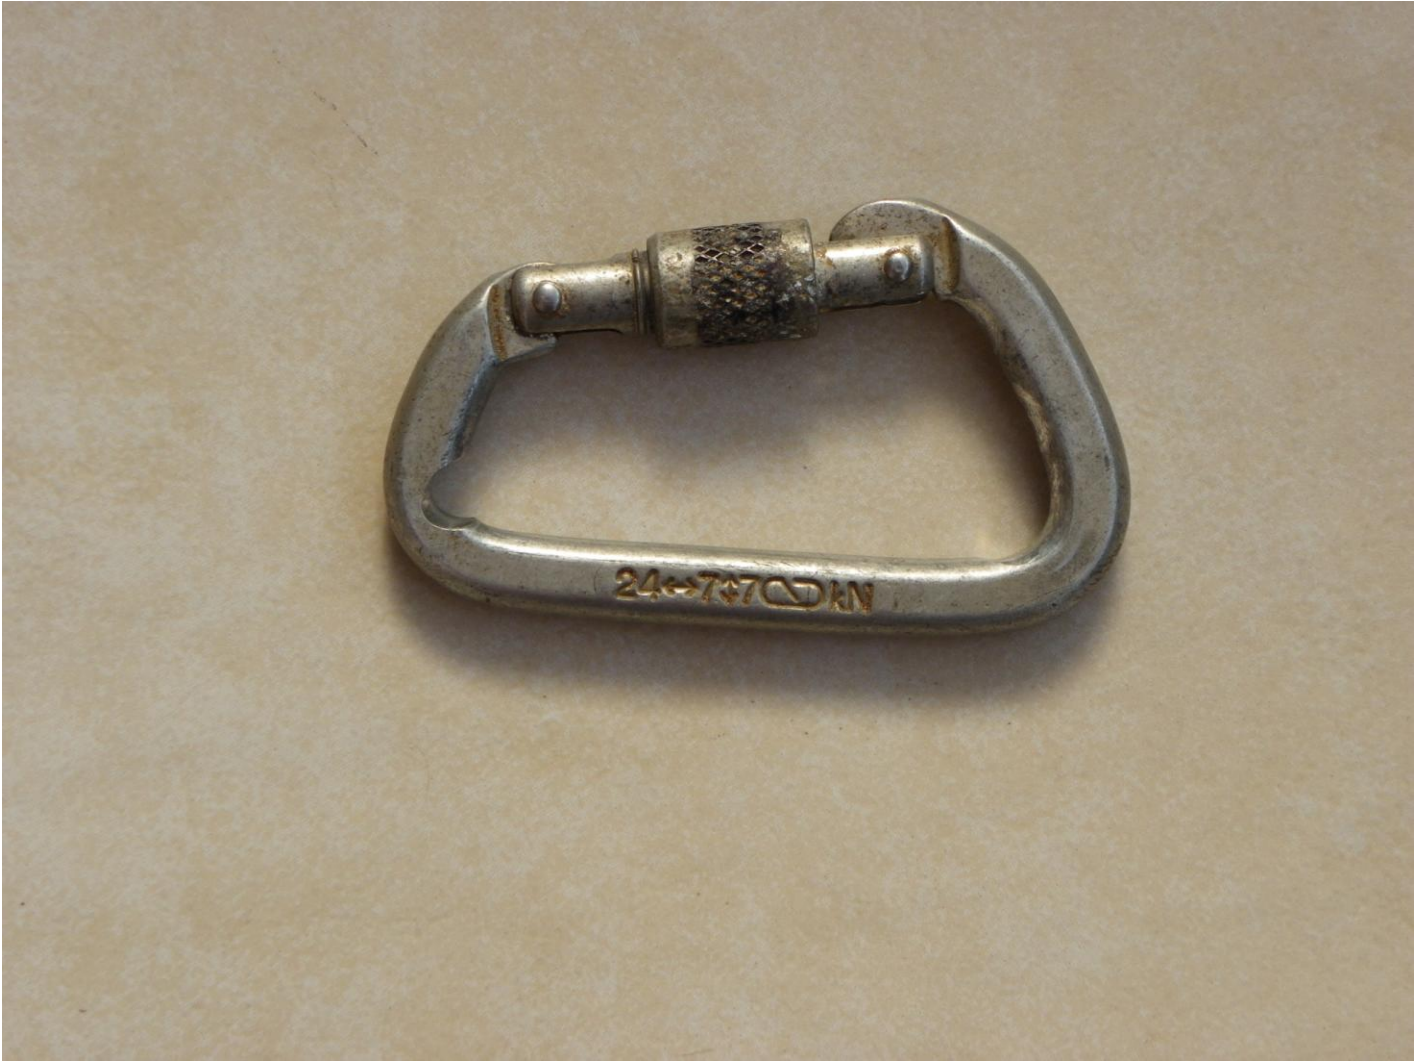
This alloy karabiner had been left attached to an Eco anchor at the bottom of a small waterfall for about 3 months
