Simpson Pot anchors signs of wear

On 14th October 2024 two anchors were removed and replaced. One from pitch before Storm Pot and one from the pitch after. Neither are long pitches. Unfortunately, the callipers we had taken to use in-situ didn't work. Both anchors were removed due to signs of excess wear on the inside curvature of the anchor.

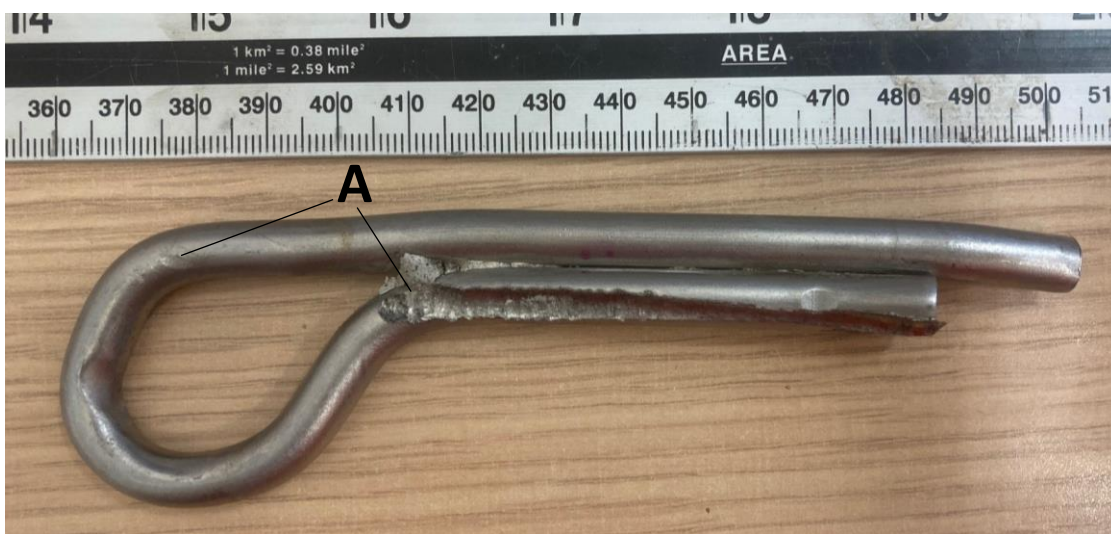
Figure 1 DMM 98A Right side view note drill marking down leg of anchor, 405-485mm.

Figure 1 and 2 show drill marking on left and right side and some wear on the inner curvature of the anchor. Figure 1 shows groove on the inner curvature. Slight polish and flattend area of the round bar shown in figure 2.

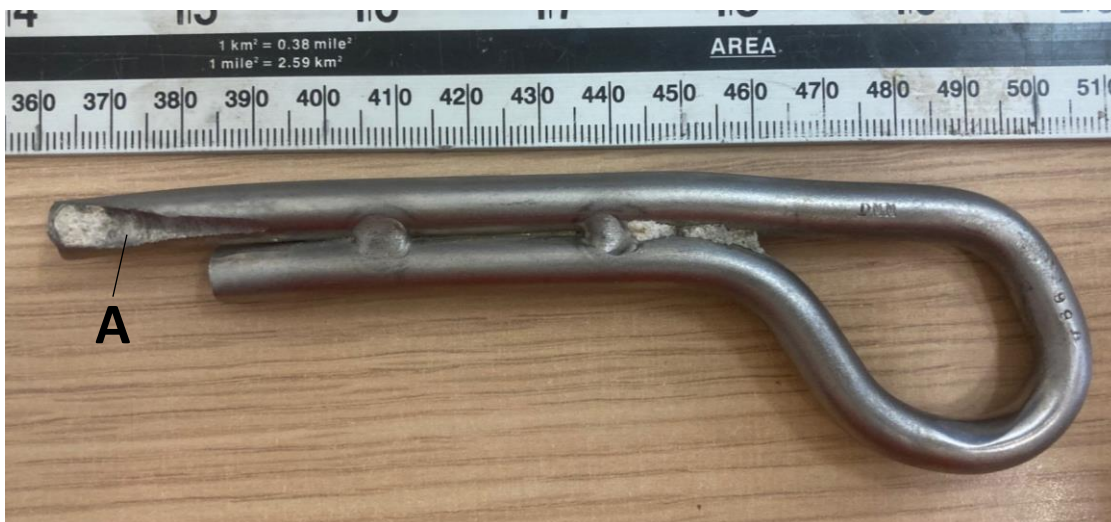
Figure 2 DMM 98A Left side view. Note drill marking at the end of the leg 395-360mm

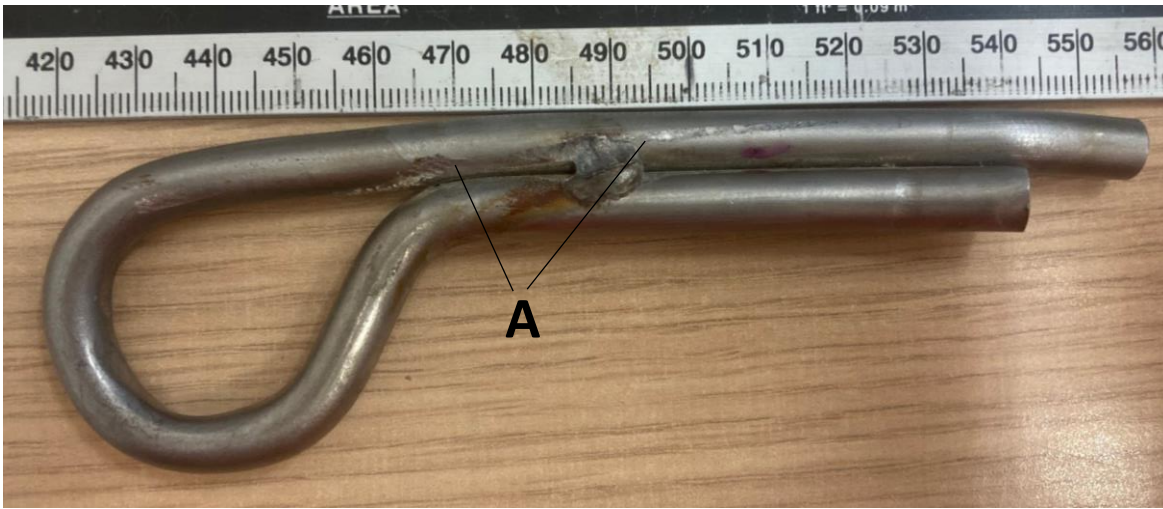
Figure 3 DMM A92 right side view. Drill marking 430, 465, 480-510mm,

Figure 3 and 4 again have drill markings. Wear isn't as clear until looking at Figure 4 where there is a flatter area.

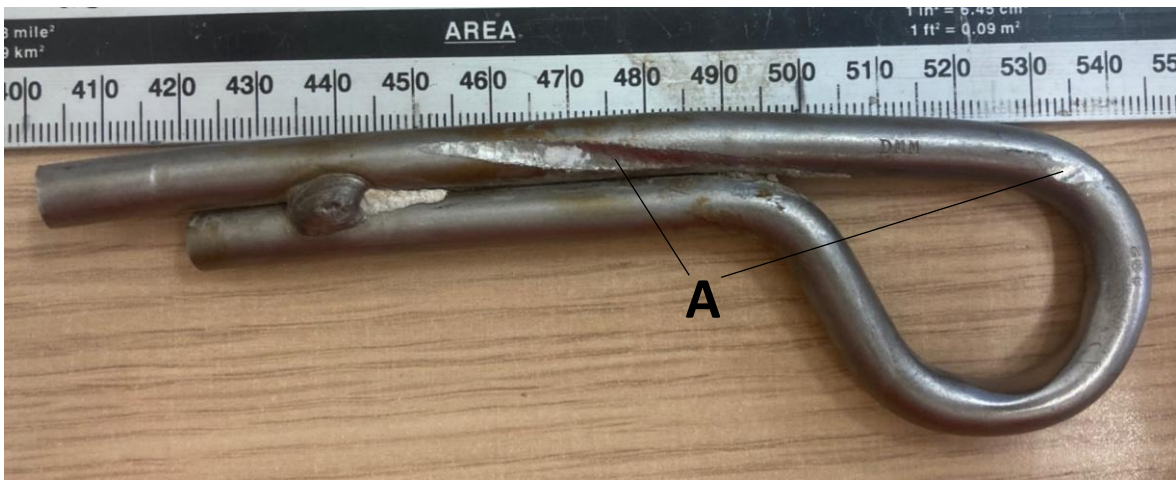
Figure 4 DMM A92 left side Drill marking 535, 500-450mm.

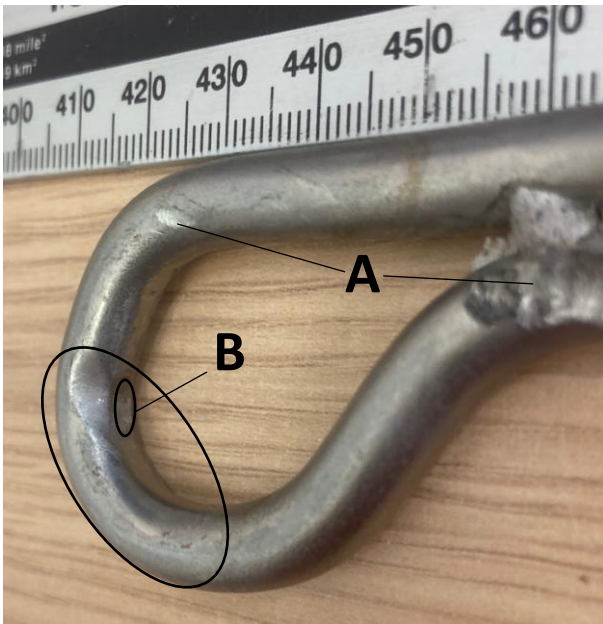
Figure 5 and 6 show the inside curvature of DMM 98A. There was a partner anchor, that would be used to form a Y hang in the opposite wall to this anchor.

Figure 5 DMM 98A right inside curvature, Note B is only the small highlighted section, the rest of the groove is wear.

Using Hamilton digital callipers an average diameter along the length of the undamaged leg was 7.85mm. The minimum diameter measured in the region of wear was 7.28mm. Giving a reduction in diameter of 7.3%.

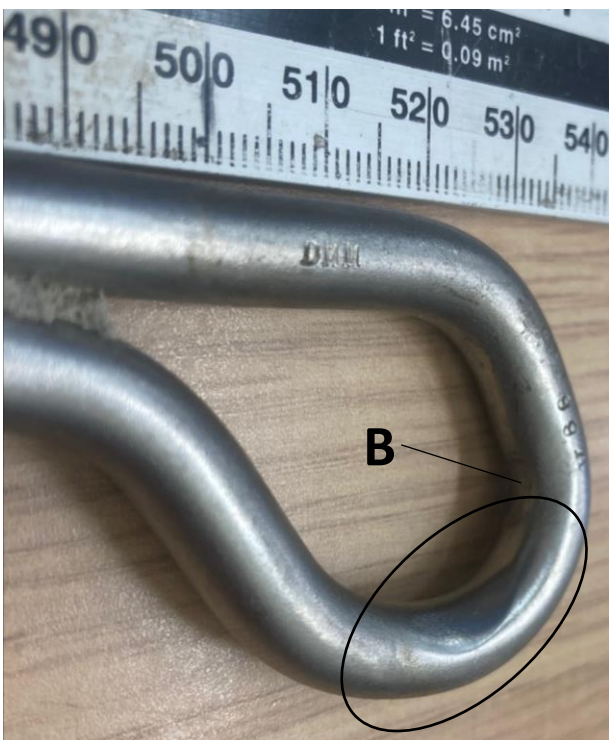
Figure 6 DMM 98A left inside curvature.

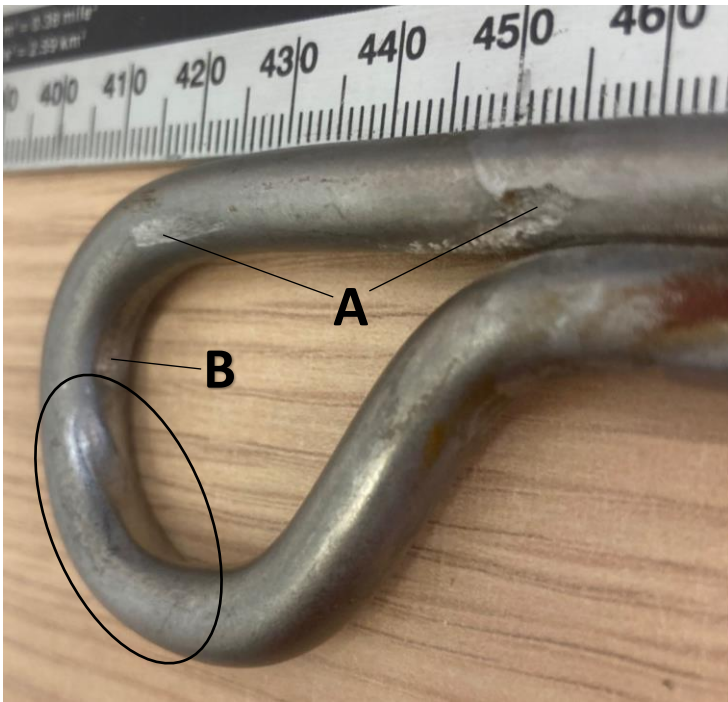
Figure 7 DMM A92 right inside curvature.

The same method was used on DMM A92 to determine the average diameter of 7.79mm. The minimum diameter measured in the region of wear was 6.74mm. Giving a reduction in diameter of 13.5%.

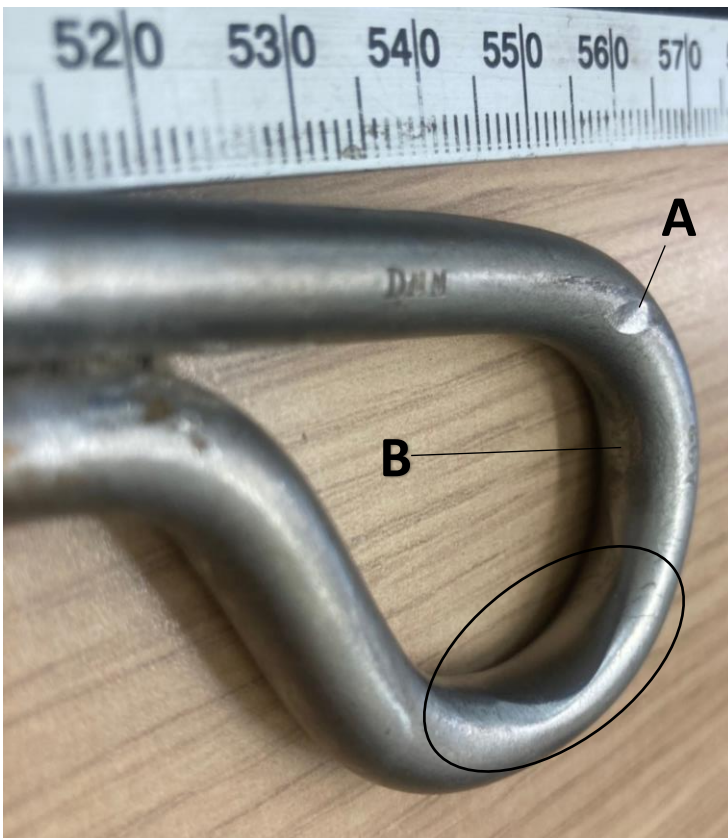
Figure 8 DMM A92 left inside curvature.

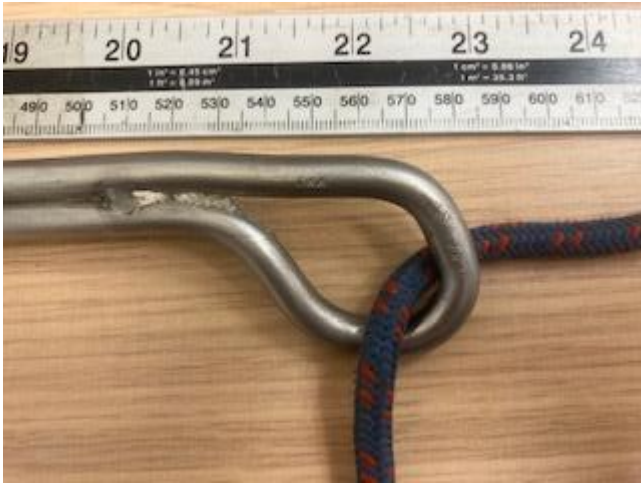
Figure 9 DMM 98A with 6mm cord layed into the grooves in the inner curvature of the anchor.

Figure 9 shows anchor with cord laid into the grooves in the anchor. This is consistent with the anchor being paired with its Y hang partner on the opposite wall, in a pull through situation. It is not as easy to determine the rope configuration on anchor A92, but this anchor clearly has had a greater degree of wear due to the larger reduction in diameter.

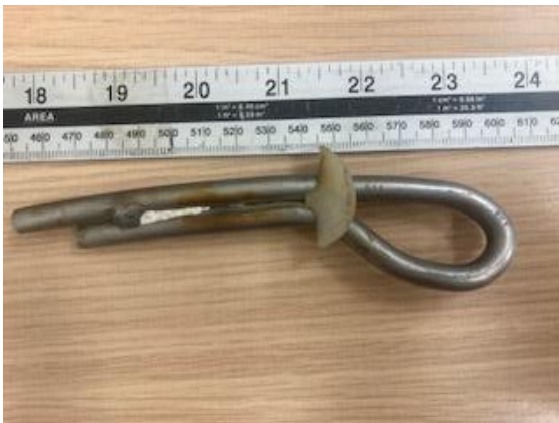
Figure 10 DMM Anchor with distorted head due to extraction, without drilling.

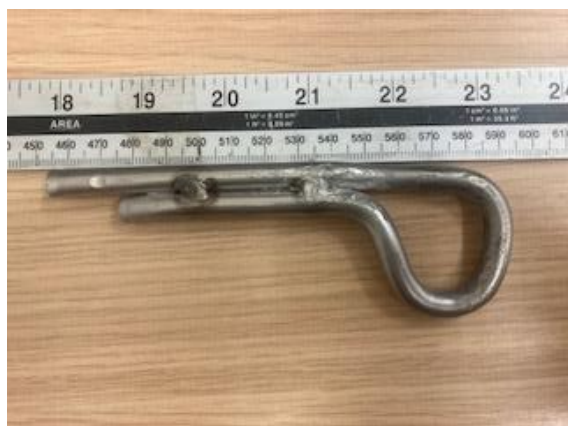
Figure 11 DMM anchor without much distortion of head but lots of drill damage.
