Witches Cave and Shuttleworth Pot

A Cave Conservation Plan Final Draft March 2012

Compiled by
Council of Northern Caving Clubs
with Natural England

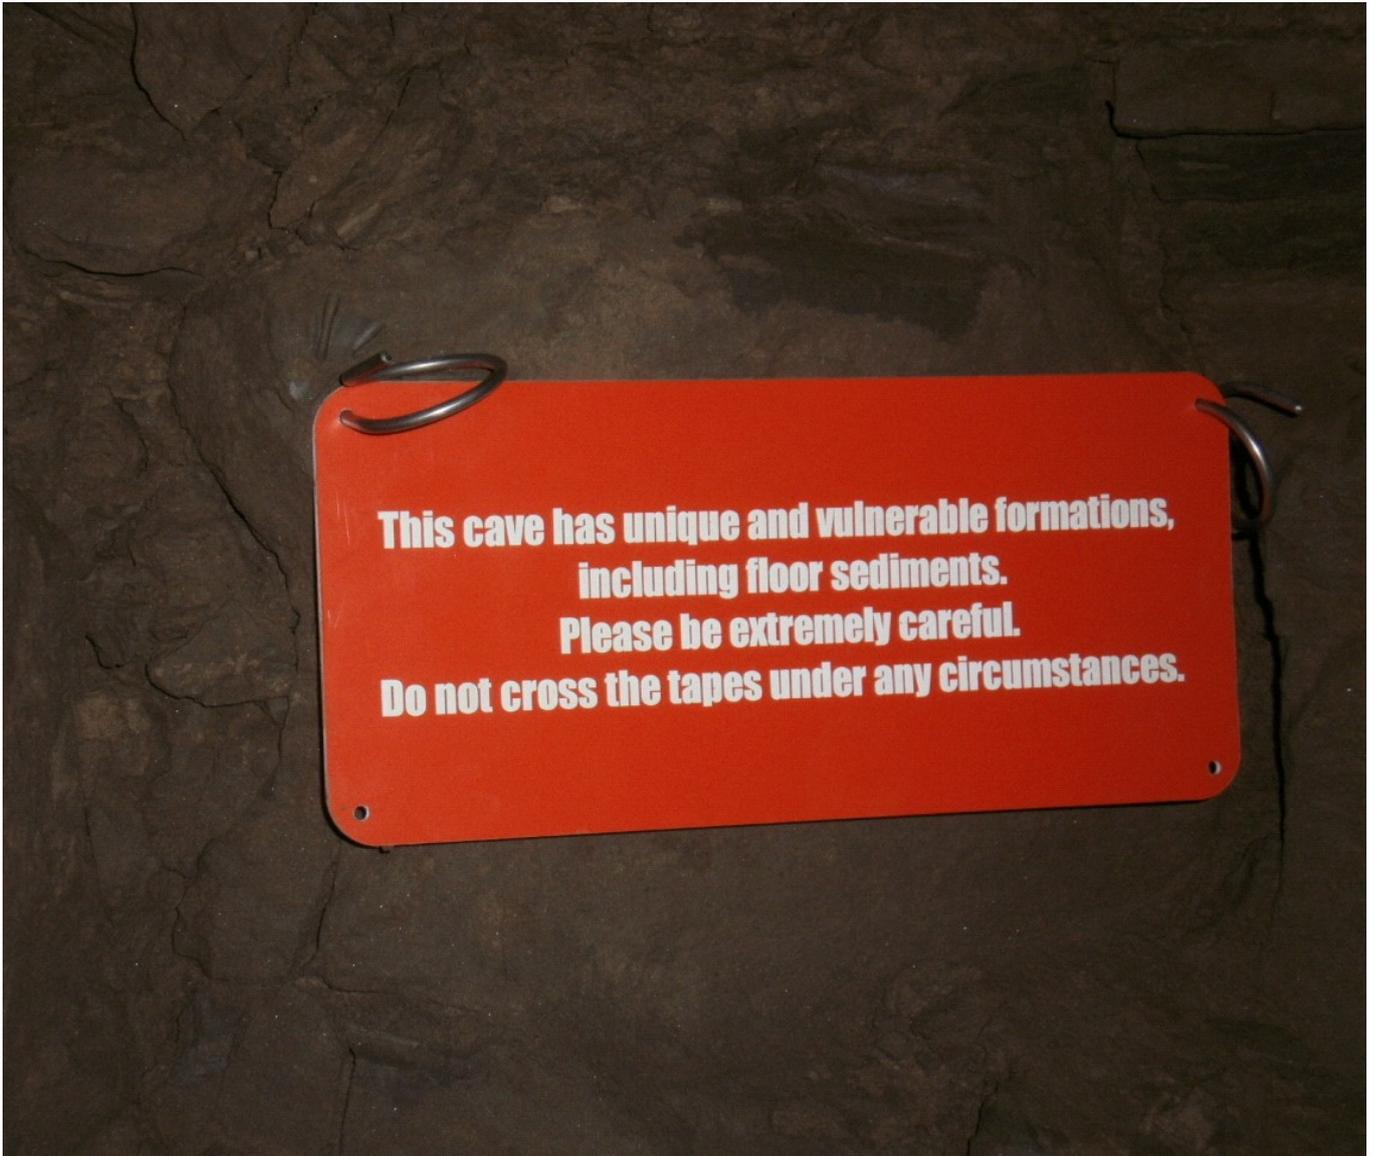
This warning sign was placed at the entrance to the south passage prior to the open season on Leck Fell. It is fixed to the sediment bank with 50 cm stainless steel conservation pins.

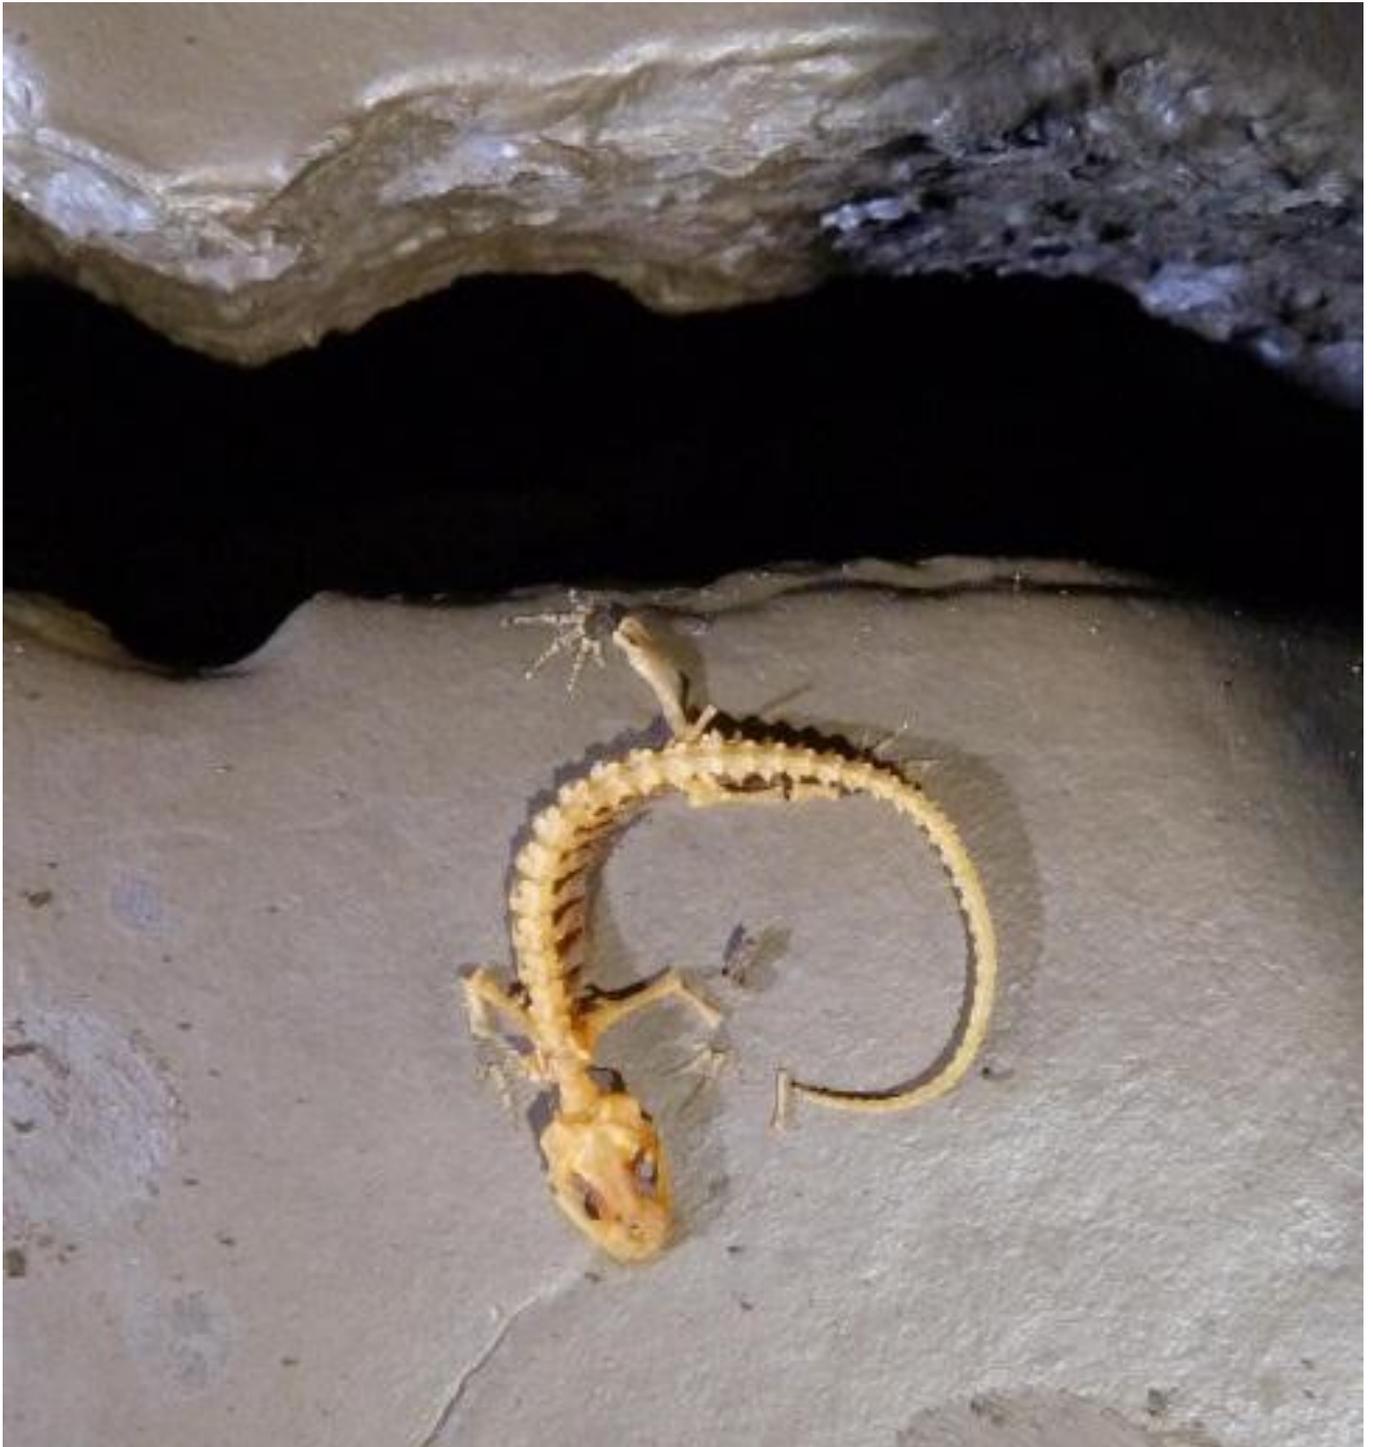
10. My Newt passage is on the left – a small passage which contains the intact skeletons of two newts, probably palmate. It also contains a fine cracked mud floor.

My Newt Passage has been taped off completely to preserve the pristine cracked mud floor, as has the Oxbow Aven area near Dogger Bank.

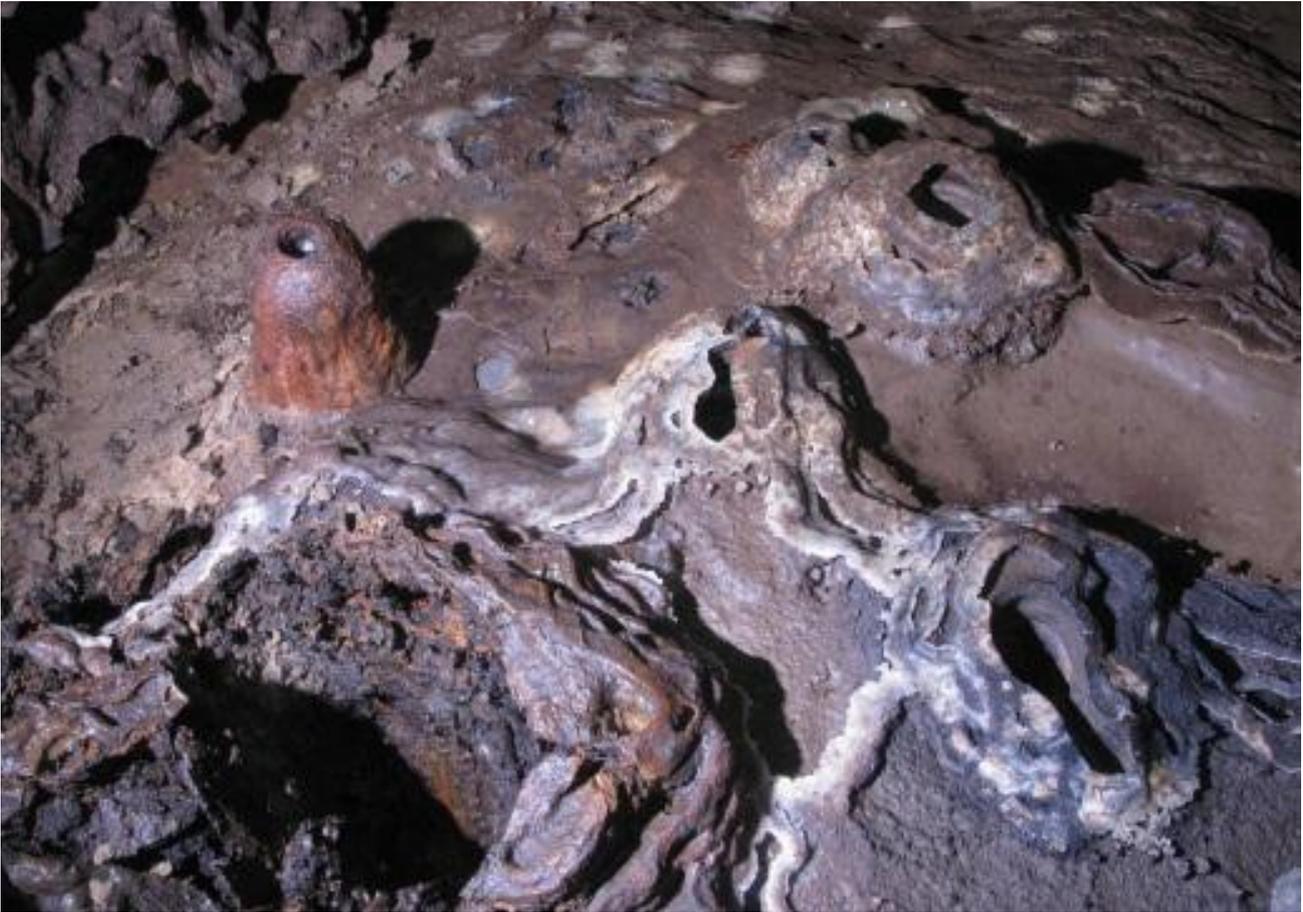
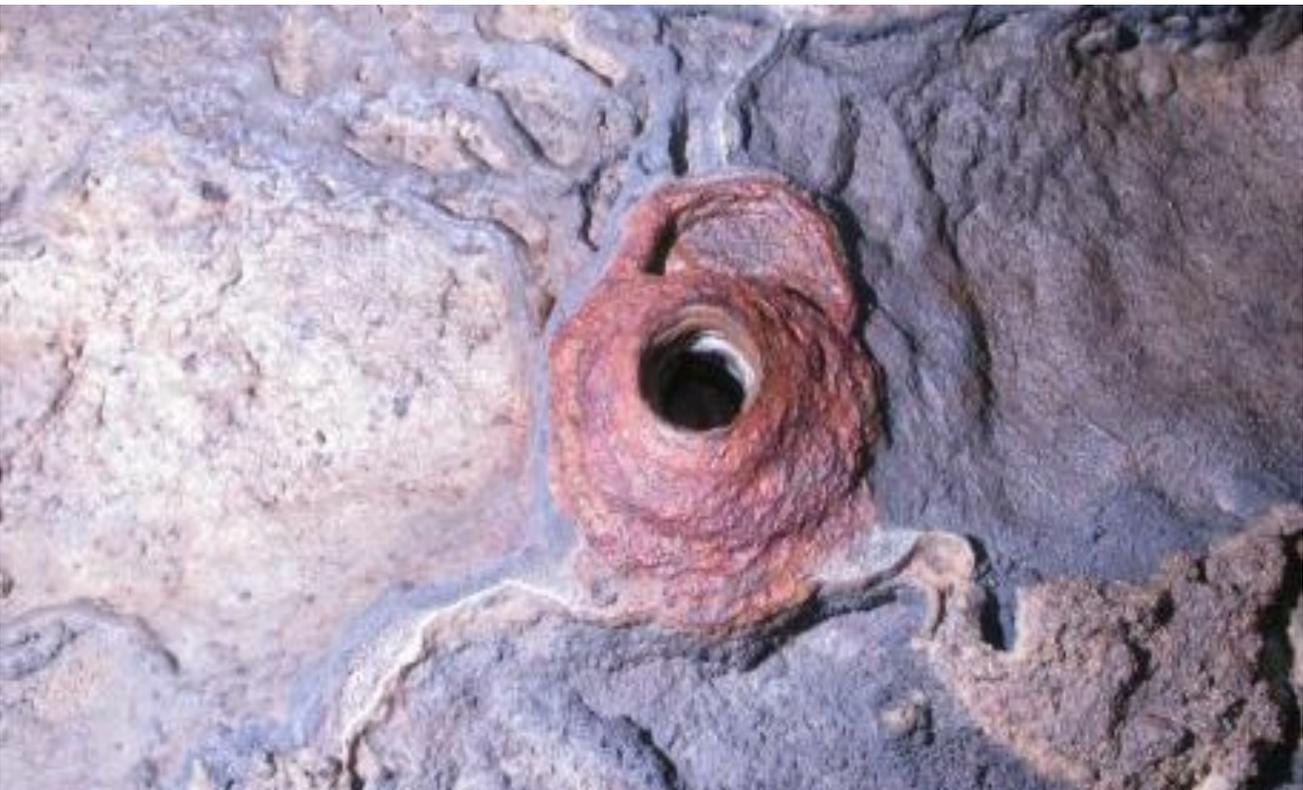
12. Clambering over a small sediment bank, the stream follows the left hand wall and passes some impressive volcano-like formations – calcite flows which appear to have had the mud inside removed by drips. These are red and brown in colour, and very vulnerable to careless feet.

The unique Volcano mud formations on the floor have had additional raised taping and remain in pristine condition.

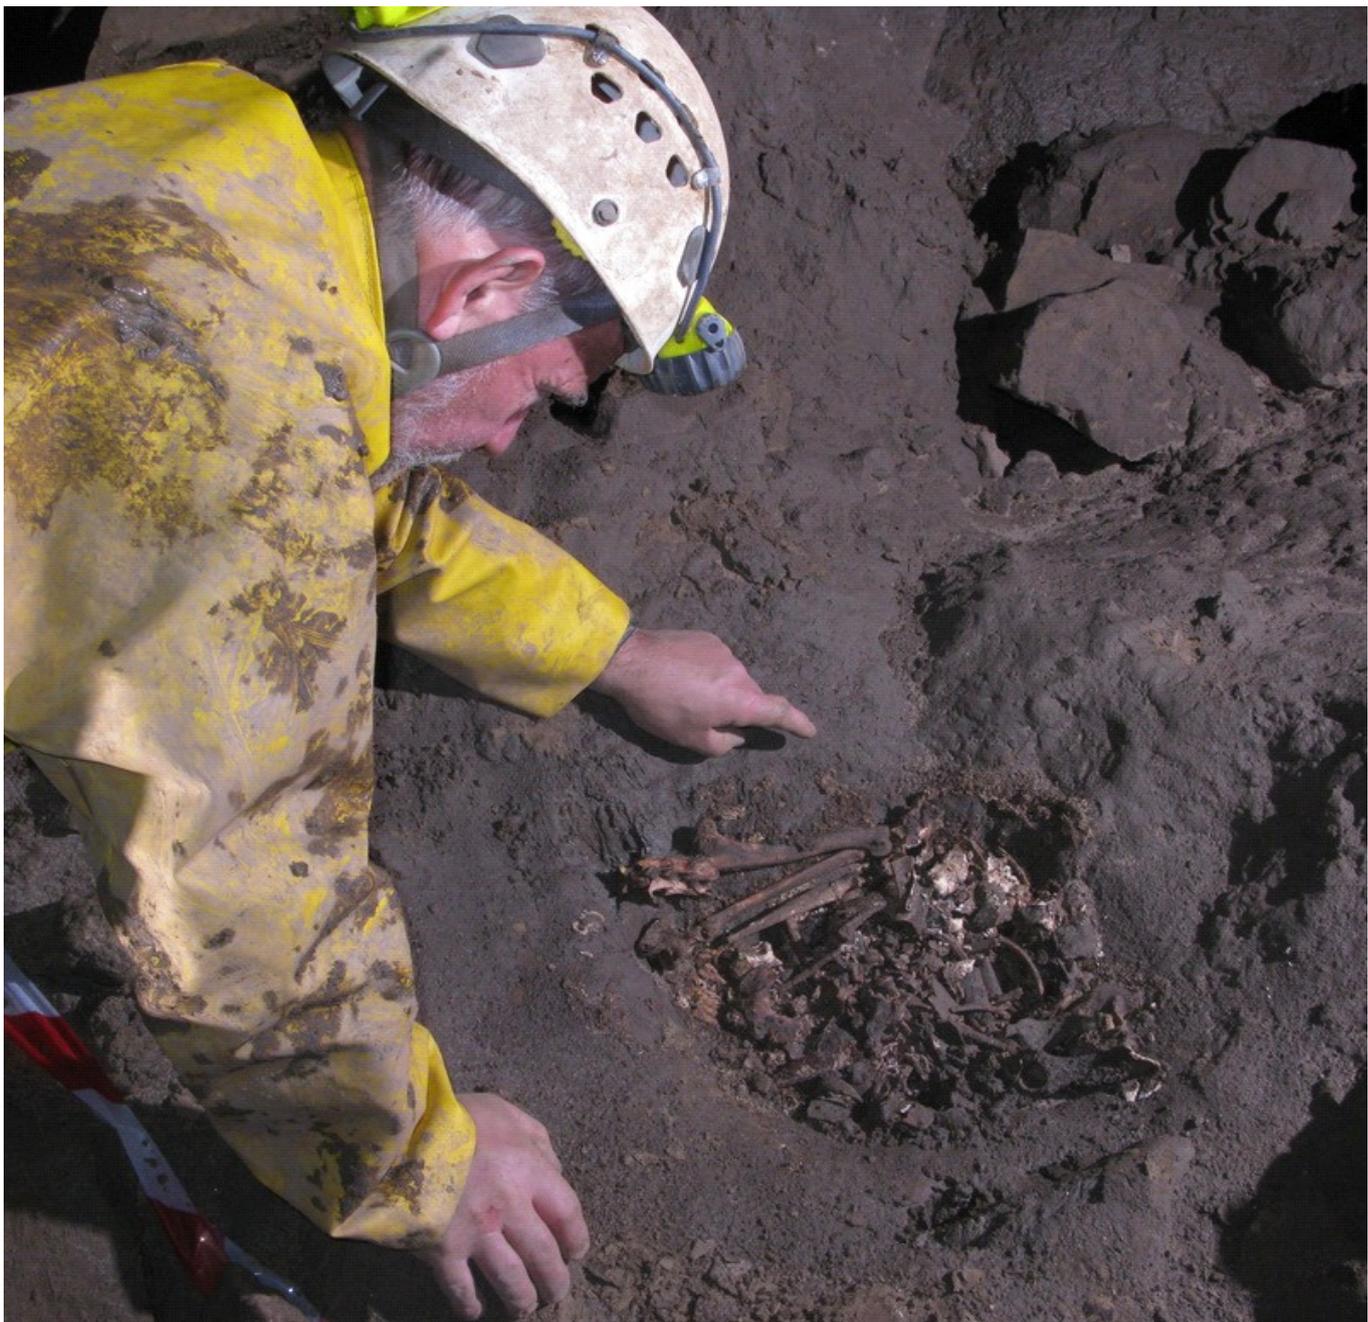
- 16.** A climb up the Dogger Bank sediment to the left leads to a small depression containing the skeleton of a dog. This has seriously deteriorated since it was first discovered as a result of excessive handling. It is not known how the dog entered the system, but when the skeleton was first seen it was clear that it must have been alive when it entered the chamber.

Dog Bones at the top of Dogger Bank:

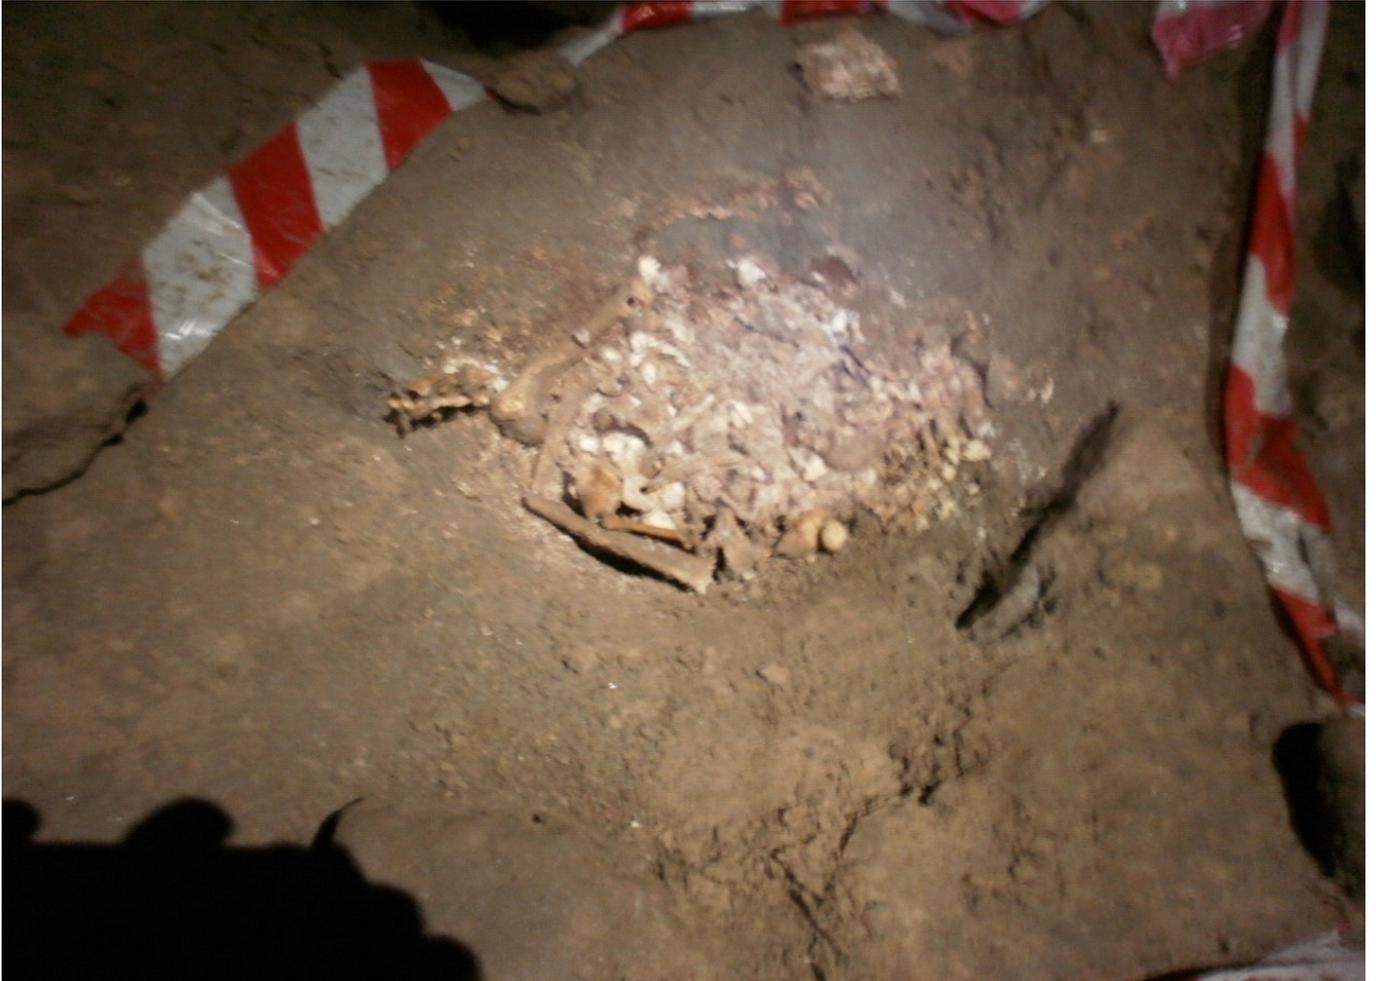
Dog Skeleton showing deterioration after five weeks of cave opening - caused by unnecessary handling by visitors.

The dog skeleton has deteriorated dramatically due to unnecessary handling.

14	Calcite drip pits	5	
15	Calcite drip pit on fallen boulder	5	Very close to path
16	Dog skeleton	2	Barely recognisable heap of dust and fragments. Too much handling.
17	Calcited mud formations and cracked mud floor	4	A few footprints have appeared on the floor formations. Further taping undertaken July 2011.
18	Shale band in roof	5	
19	4m high varved sediment bank	5	Vulnerable to erosion at base despite taping
20	Forest of 2m long straws	5	Floor formations adjacent to straws vulnerable to photographers and models footprints. Well taped.
21	False floors	5	well out of reach
22	Oxbow—well decorated	5	taped out of bounds
23	Multiple avens	5

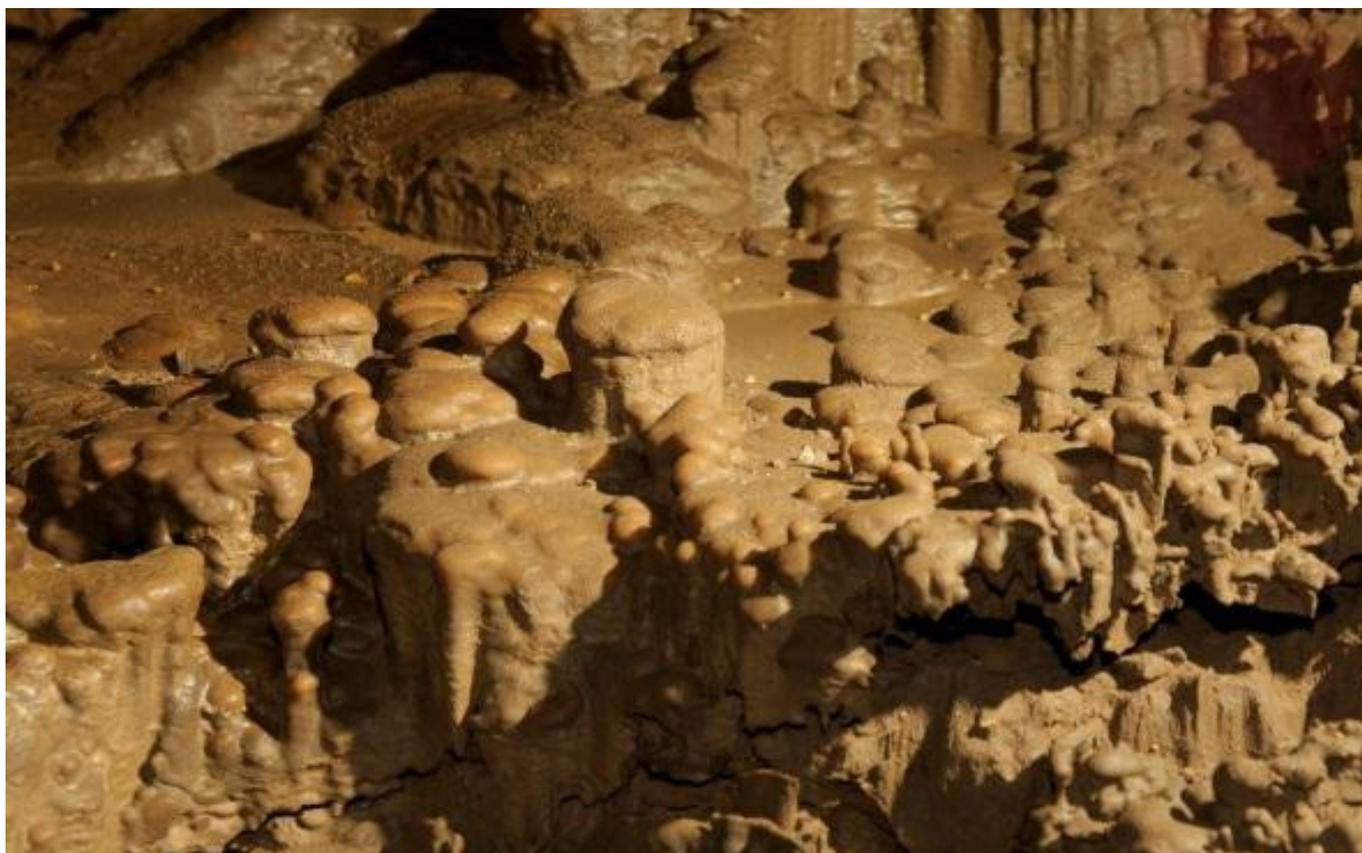
17. To the left of the dog are some unusual calcited sediment formations fed by a 6 m high calcite flow on the wall, and on the right the un-trodden sediments exhibit polygonal cracking and contain drip holes. The sediment in this area is vulnerable to trampling, although it has been taped.

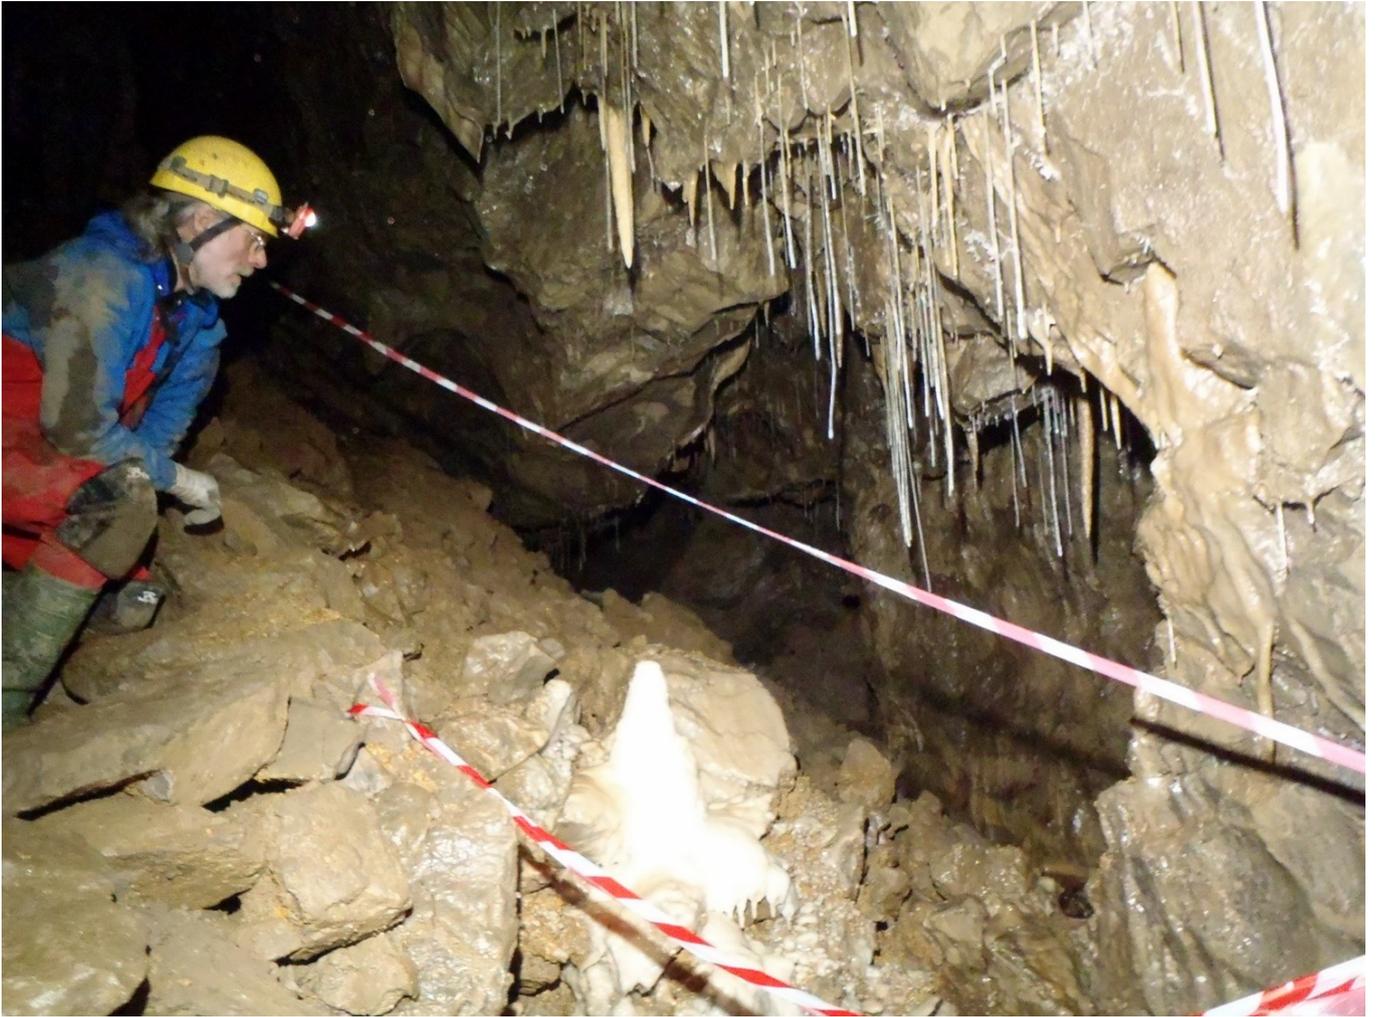
22. Before the aven is reached, a well decorated oxbow takes off on the right. This has been taped off to minimise damage.

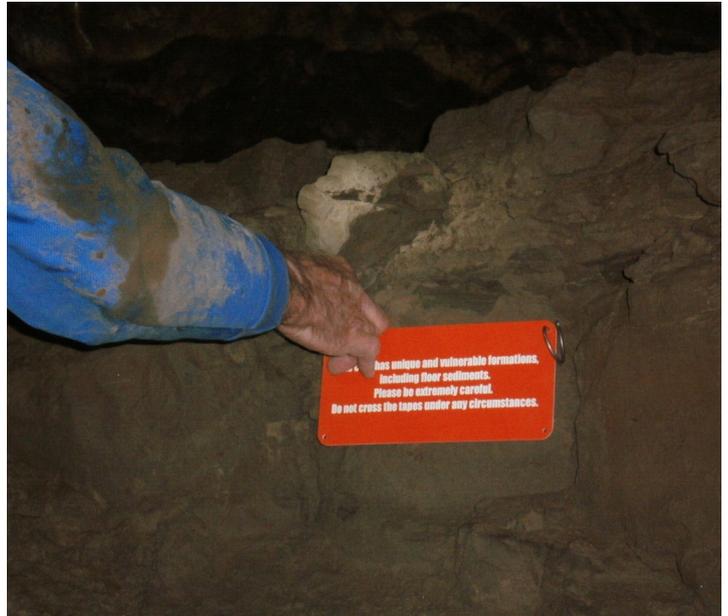
The whole of the south passage is taped using stainless steel tape hanging rods to create a desired route through this fragile area of floor deposits. There is no need or excuse for crossing any of these tapes. A plastic sign has been placed at the start of the south passage explaining the function of the conservation tape
