## Bolt Products Anchor Test Report 22<sup>nd</sup> October 2011

This test report is for the Bolt Products 8mm twisted stainless steel bar anchor.

### Ingleton Quarry 05<sup>th</sup> October 2011

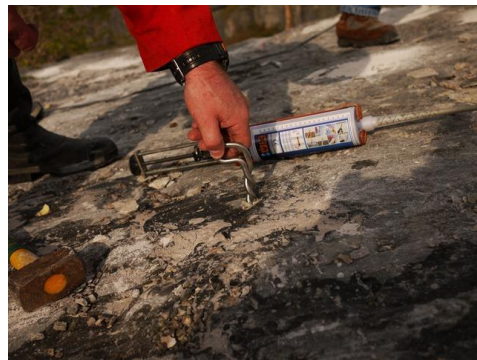
During the test period it became apparent that the chemical anchor mortar had not thoroughly mixed during application into a hole. The peak load to remove this anchor was 36kN. RAWL have been contacted and from the information supplied by us have initiated an investigation.

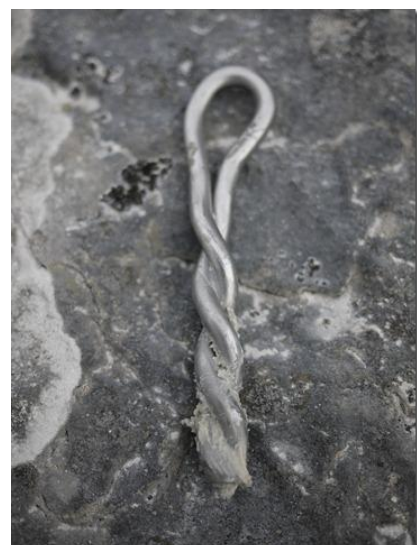
The failure mode initially is similar to a DMM Eco anchor with elongation of the eye towards the direction of the applied load. However, unlike an Eco anchor as it is extracted from the substrate the anchor twists until the load is released as the anchor suddenly egresses from the resin; the load is then gradually increased until the anchor starts to twist and the process is repeated until the anchor is extracted from the substrate.

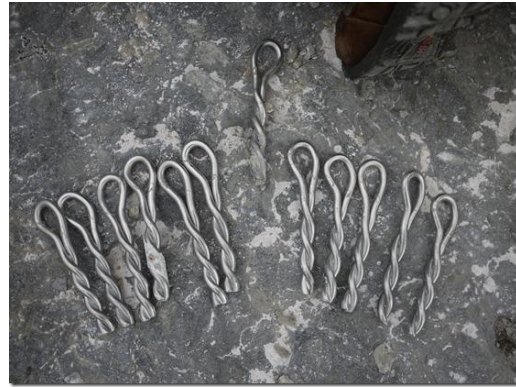
The disparity in peak load range (24kN) is due to the resin as is indicative of the mode of failure. Although there is enough strength in the system offering an acceptable safety margin it is apparent that the resin does not provide consistent results as demonstrated in the peak load figures.
