Witches Cave and Shuttleworth Pot

A Cave Conservation Plan Final Draft March 2012

Compiled by
Council of Northern Caving Clubs
with Natural England

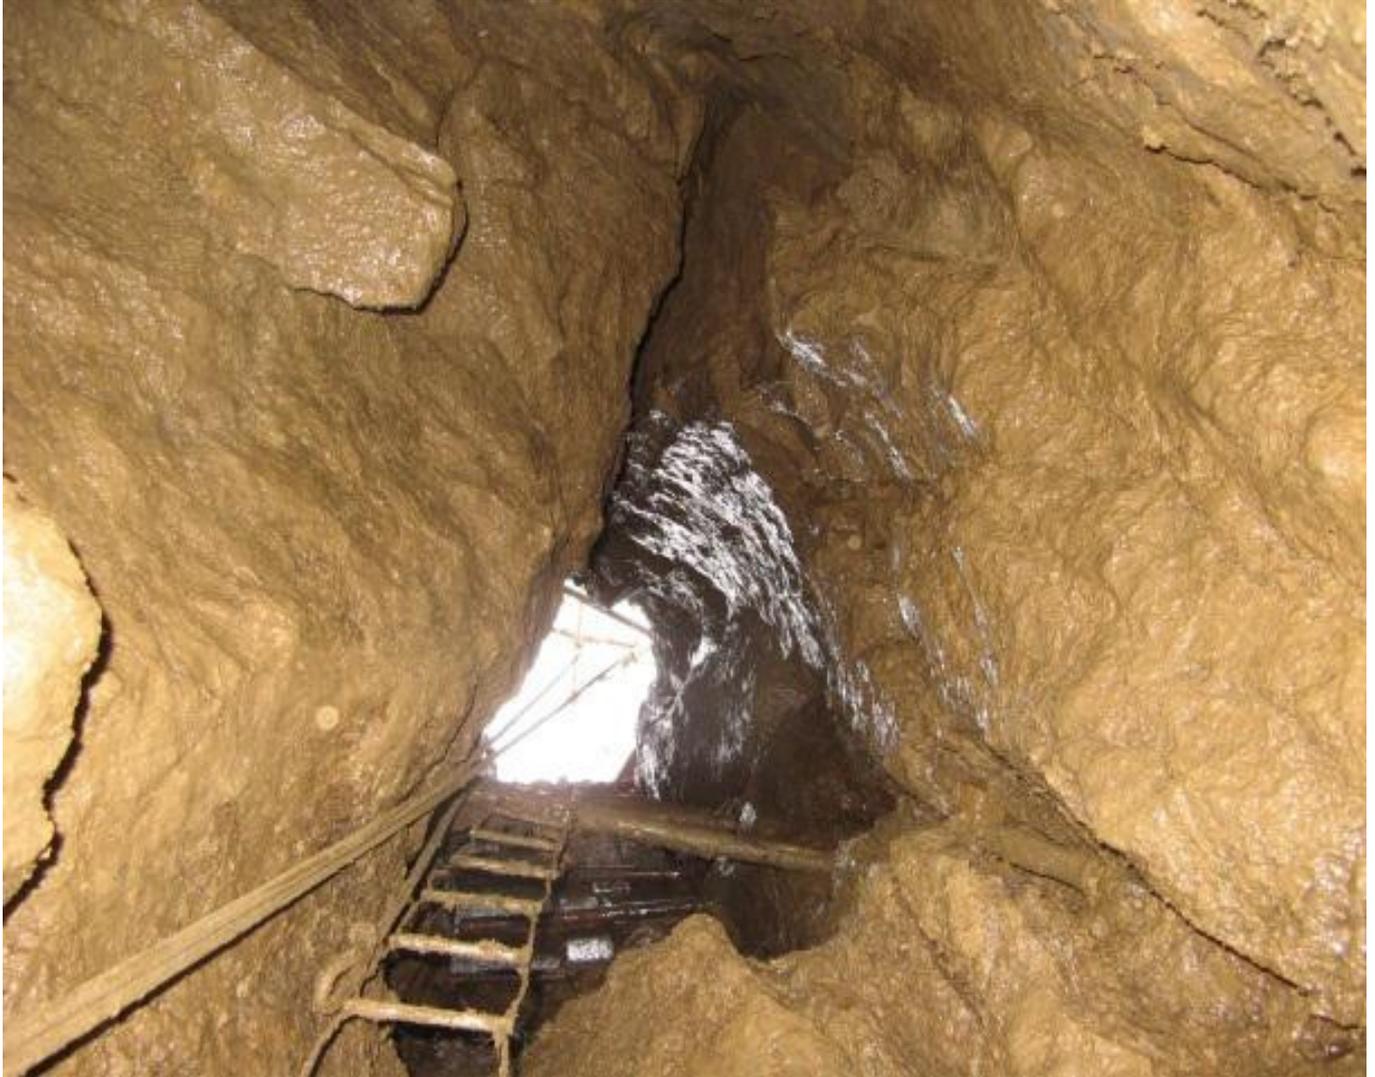
1. Shuttleworth Pot – a small 17 m deep shaft originally filled with limestone clasts up to boulder size, and clay. An assemblage of bones which included aurochs, wolf, and human unearthed from the lower half of the choked shaft indicate that the shaft has filled since the mid-Holocene. The shaft enters a small steeply descending passage to arrive at the top of Diver's Pitch.

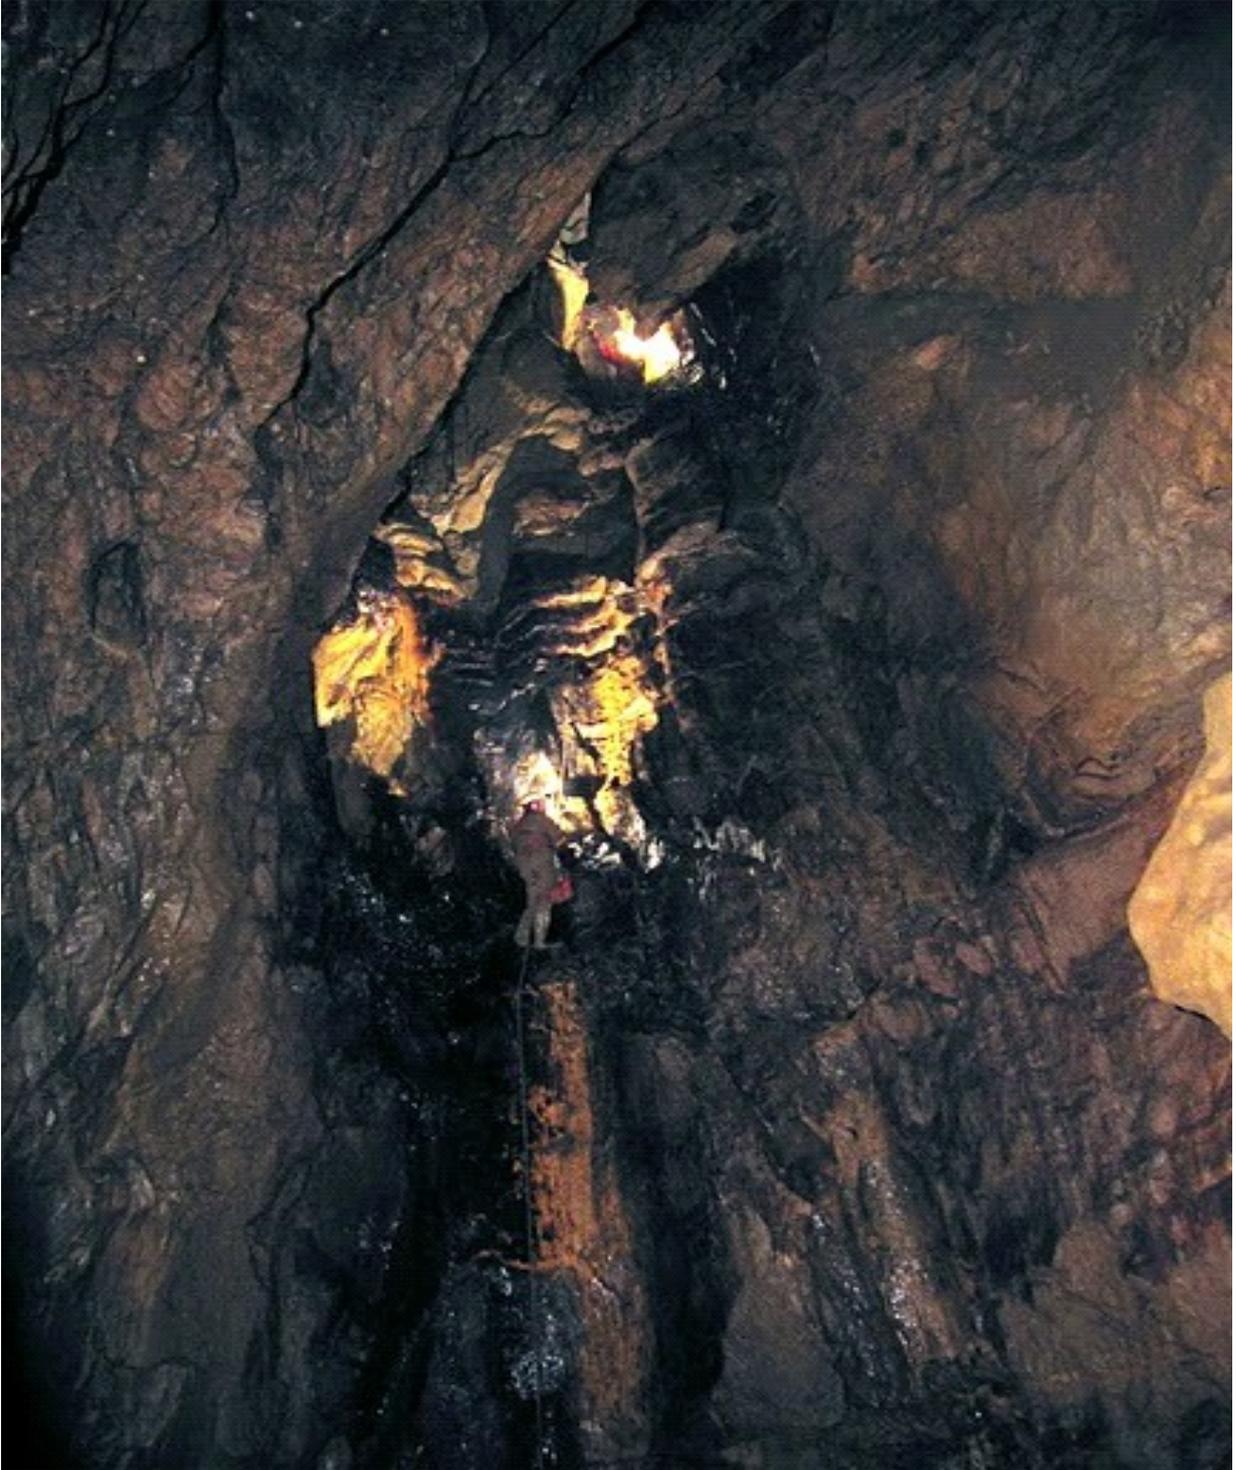
2. Diver's Pitch is a 25 m pitch which enters a large chamber formed within the main Witches II passage oriented along a 4 m wide north-south fracture zone. The chamber has formed where at least four large avens enter from above, introducing drainage which washed away the considerable depth of sediment. An assemblage of bones found on the floor of this chamber included horse and pig – indicating that one or more of the shafts were active up to the Bronze Age. To the north, an almost vertical wall of rubble drops 10 m to the active stream way. A large phreatic tube can be seen in the roof extending from the passages to the north over the window into the streamway to the Exercise Yard (Location 29).

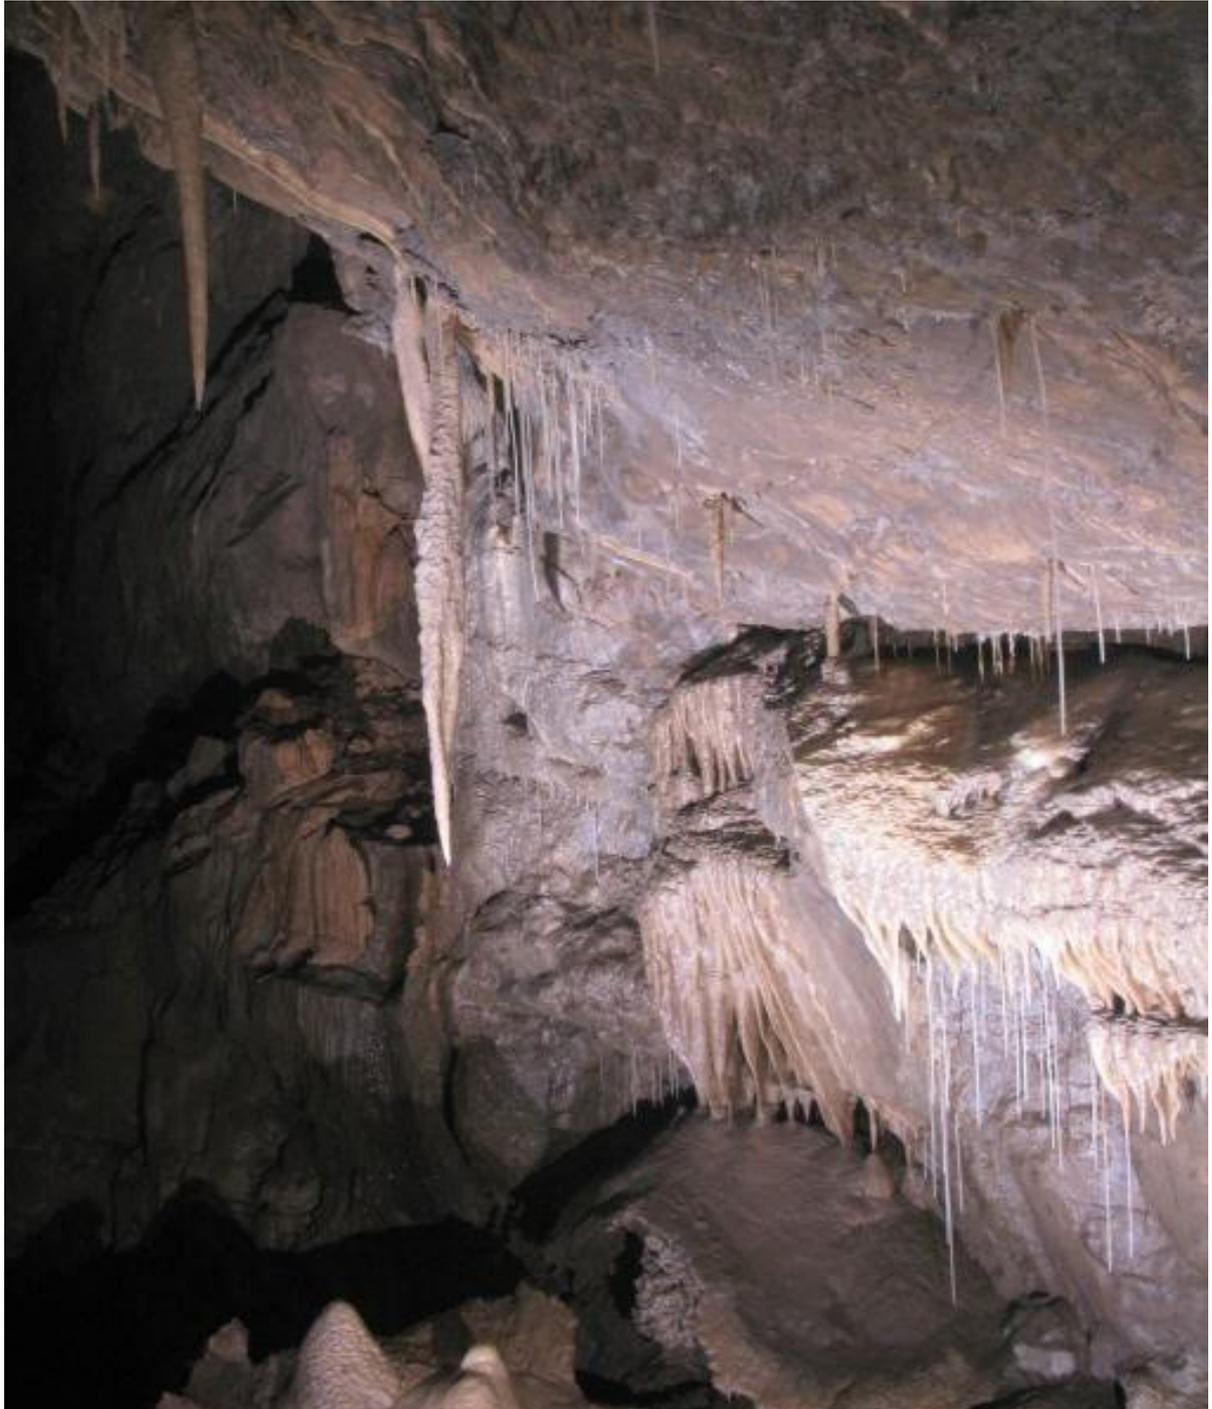
3. From the Diver's Pitch the sand and clay sediments rise up a slope to the south to where the passage becomes low. Towards the top, a 2 m long stalactite feeds a large stalagmite boss and calcite flow resting on the sediment on the left. On the other side of the passage a calcite curtain hangs from the roof. Flow markings indicate a flow to the north.

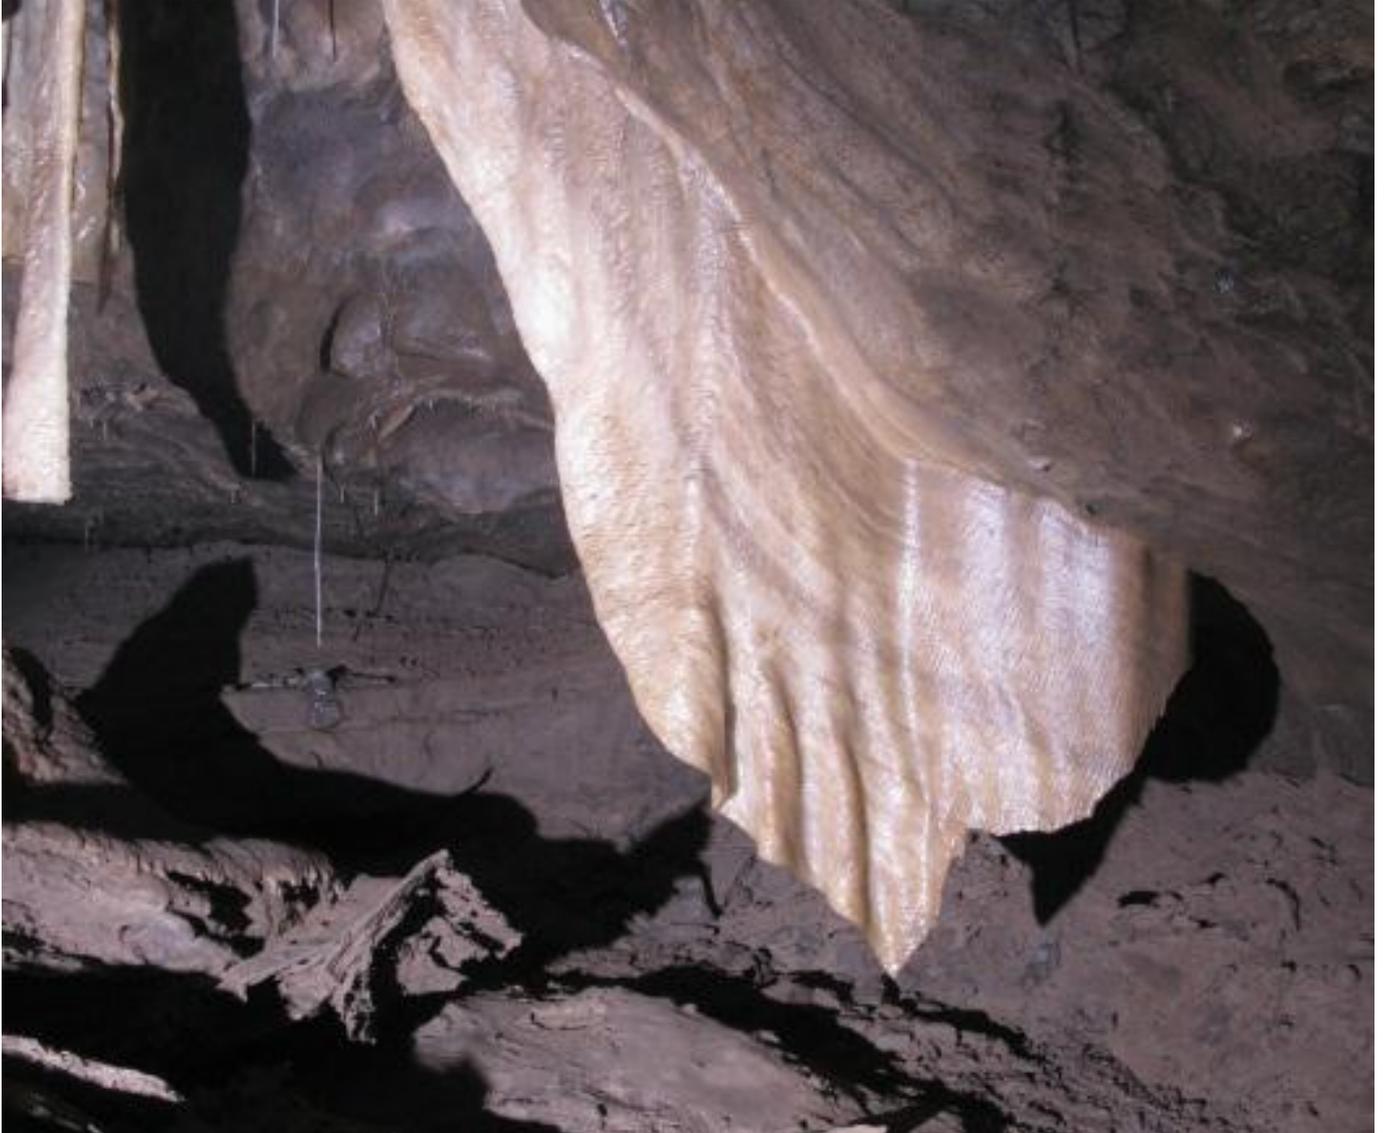
- 10 m into the crawl at the top of the slope there is a group of calcite curtains on the right. The middle one once formed a column 1m high, but the 2 m wide calcite base resting on sediment has slipped into a shallow gully, leaving the top and bottom offset by 20 cm. The shallow gully indicates that there has been some post-sediment flow in the passage towards the north.

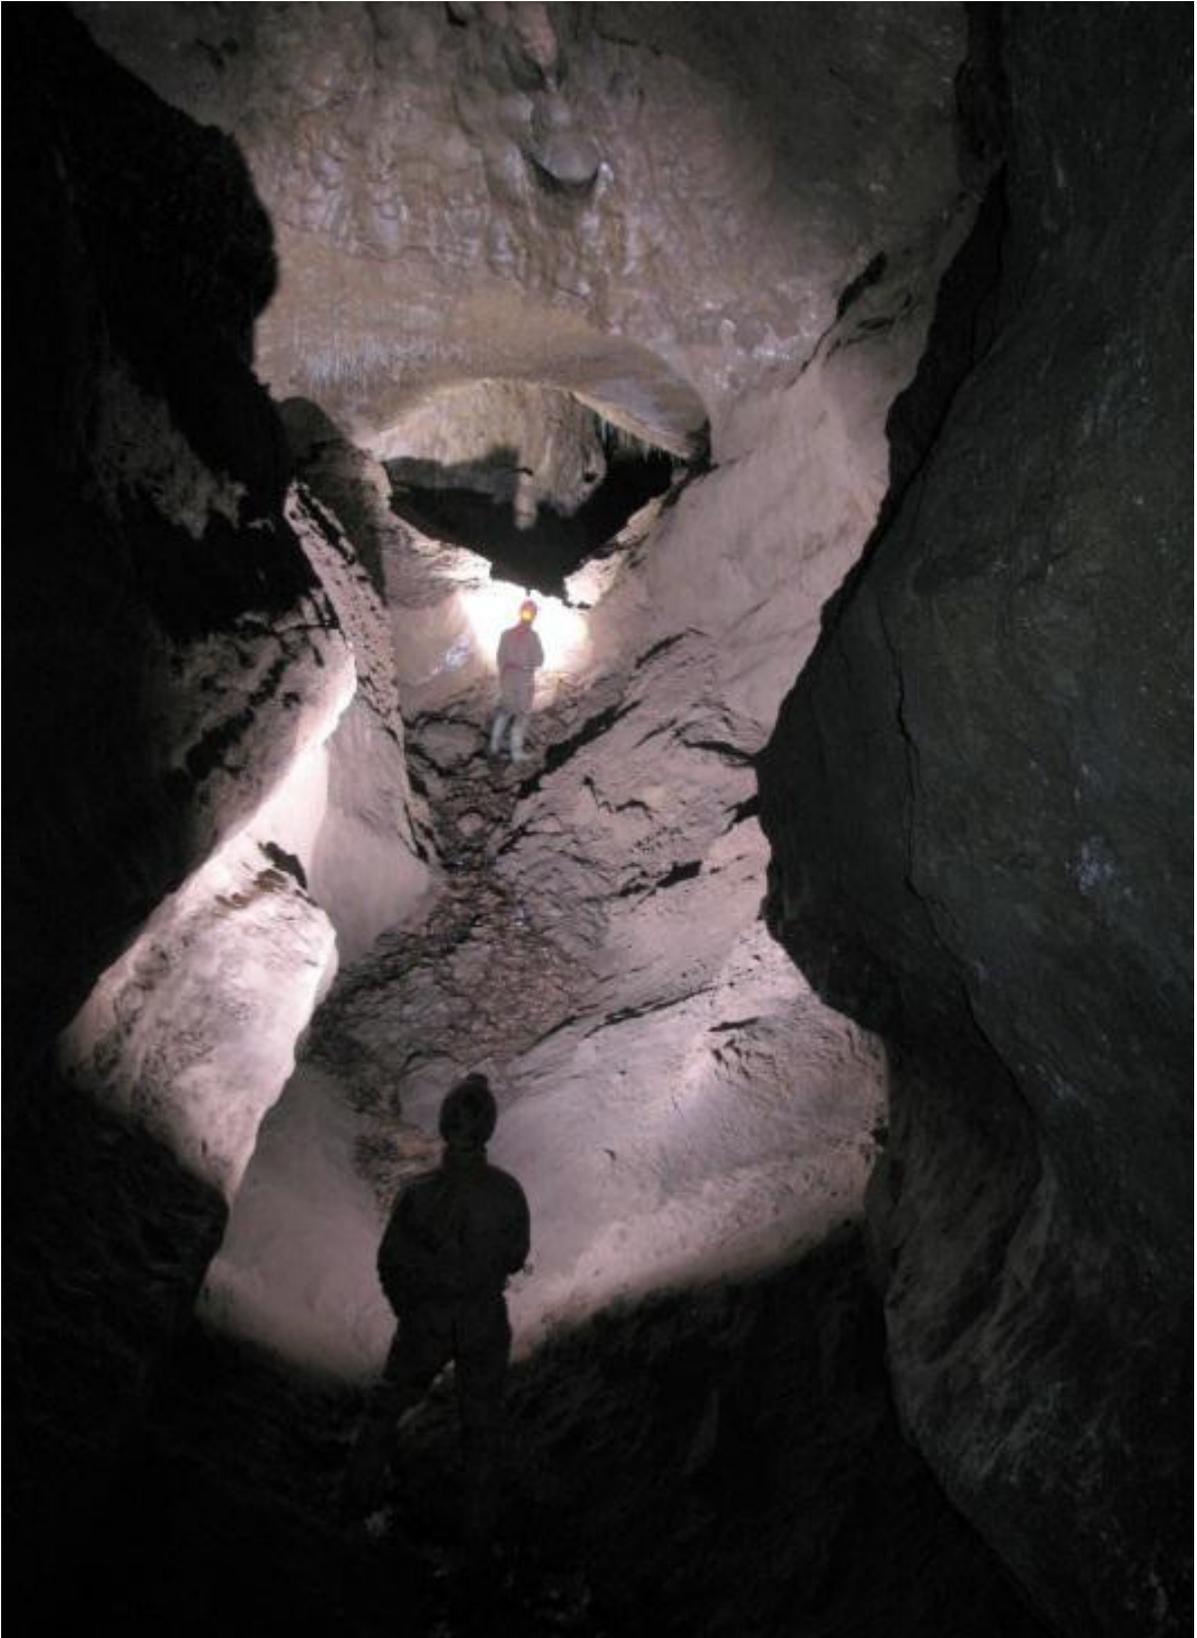
7. The canyon contains a misfit stream sinking towards the same fissures as the water from the active aven, and contains three prominent notch marks. A 4 metre wall of sands, clays, and cobbles can be seen on the left near to the top.

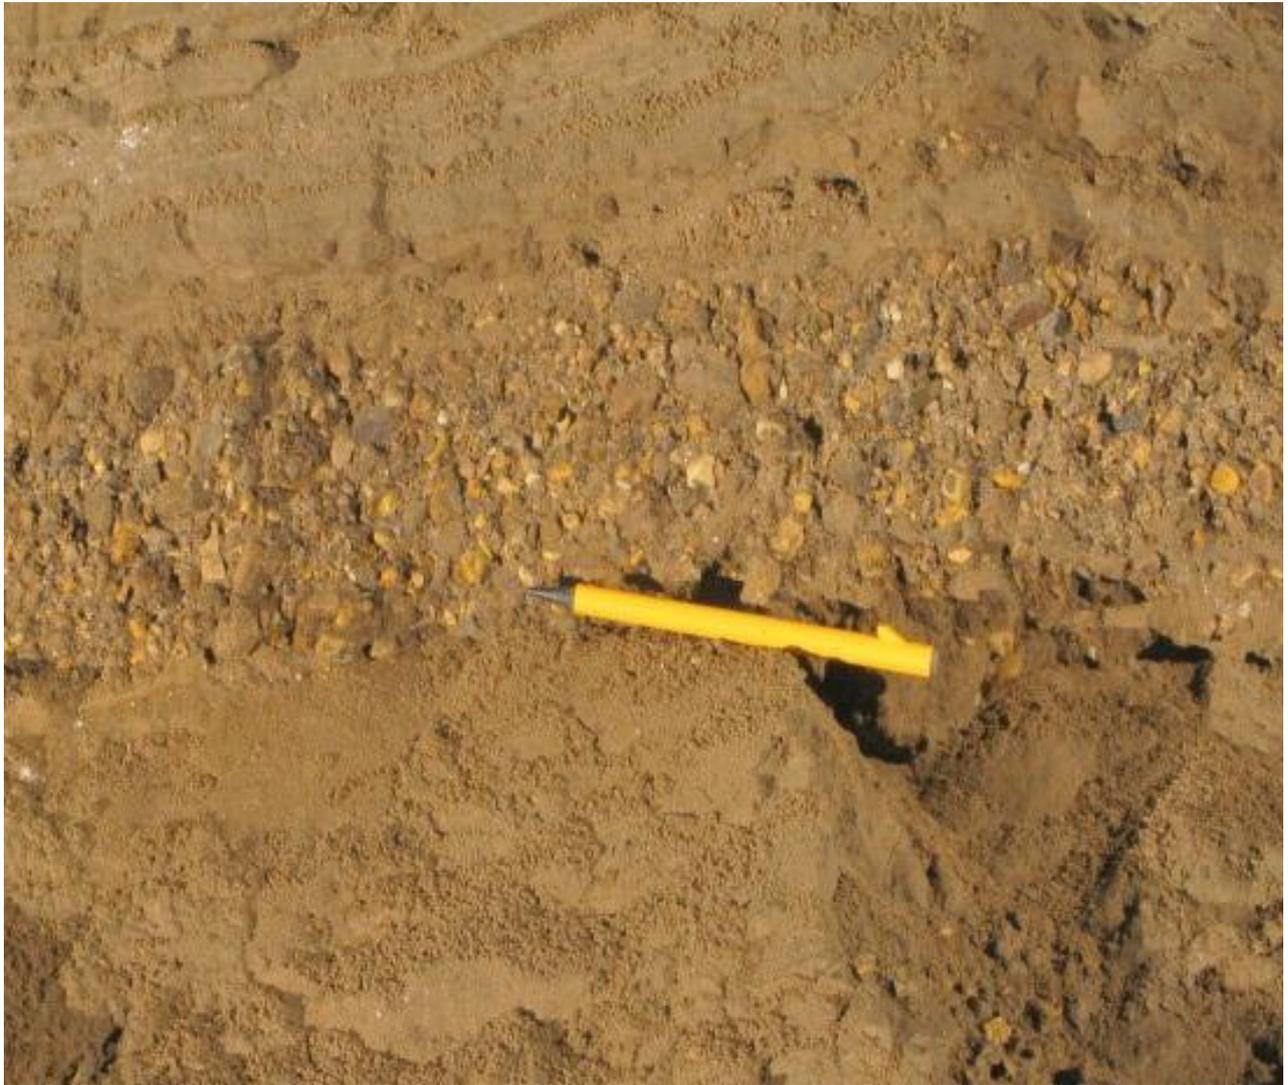
8. Detail of sands, clays, and gravels in the canyon. The light band of gravel was deposited on top of the eroded sands and mud during fluvial re-invasion

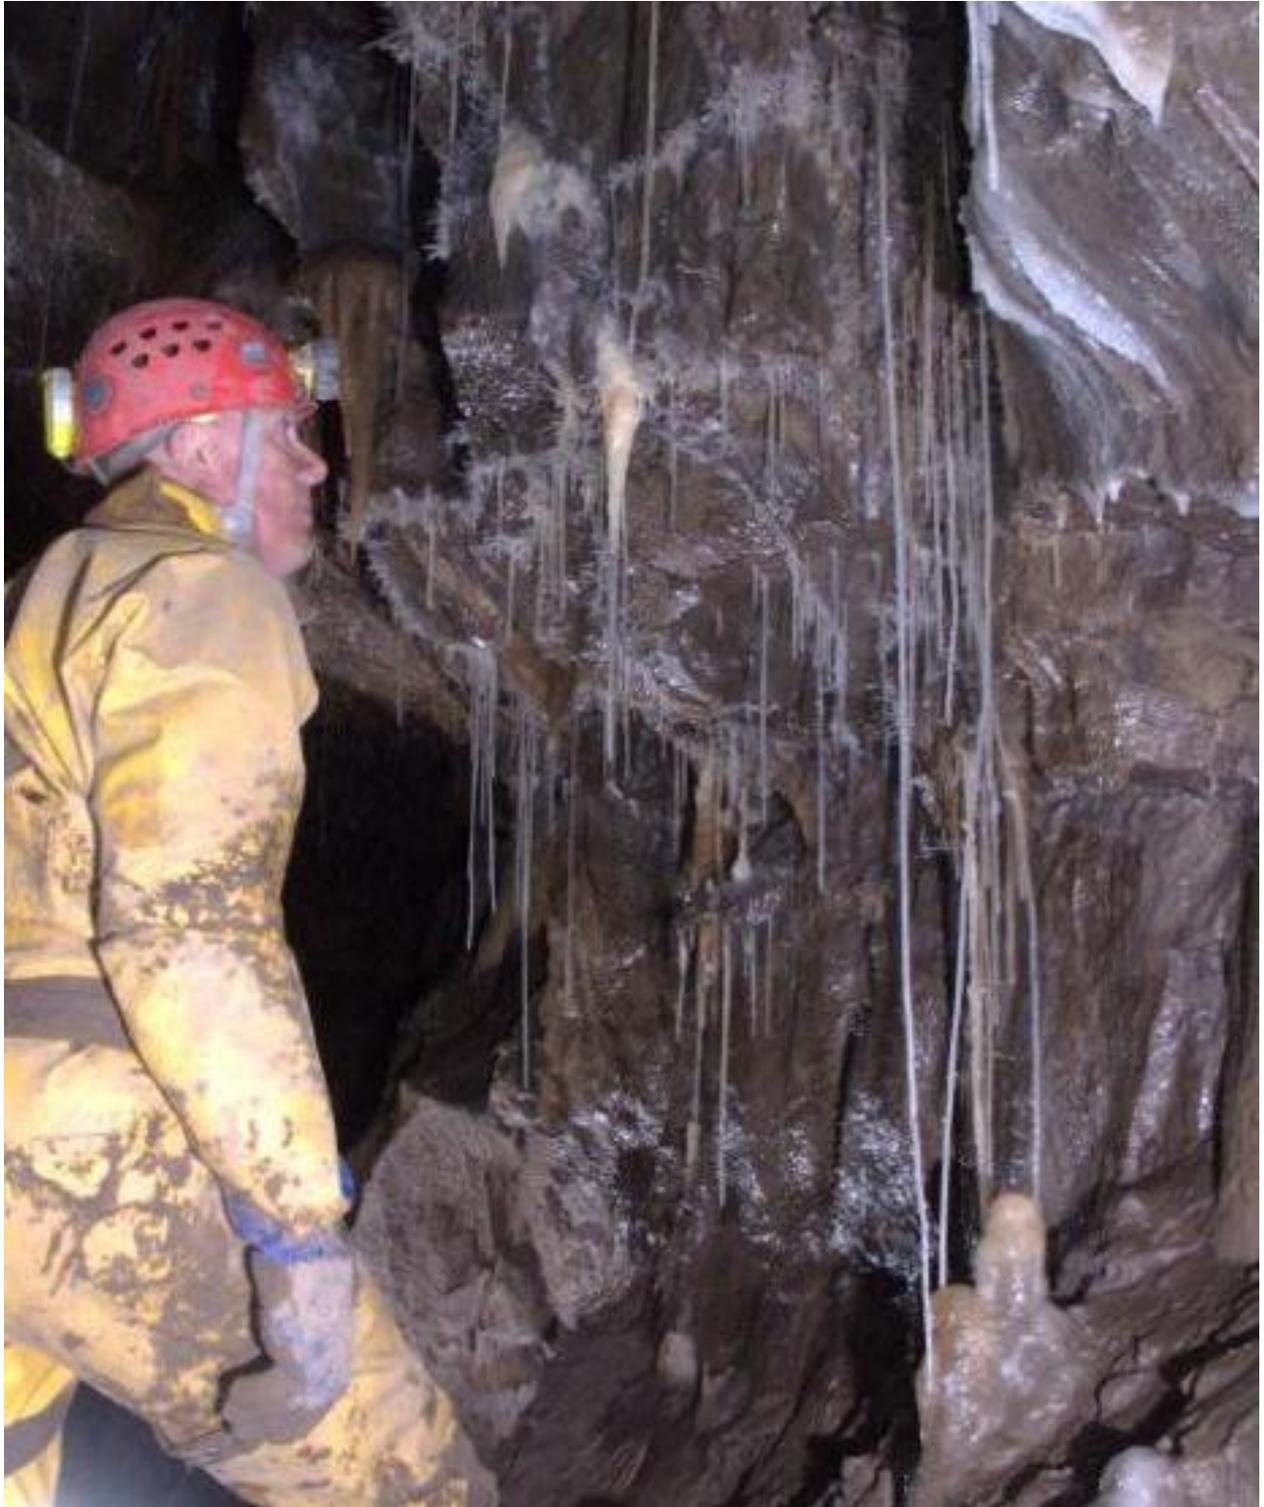
9. The passage ascends steeply for 4 m, temporarily losing the stream. There are several calcite straws up to 2 m long; an ornate curtain in the roof, and a finely banded curtain at floor level on the left. There is a 1 m straw column on the right. At the bottom of the slope there is a large section of fallen false floor standing on its edge, which has been recalcified.

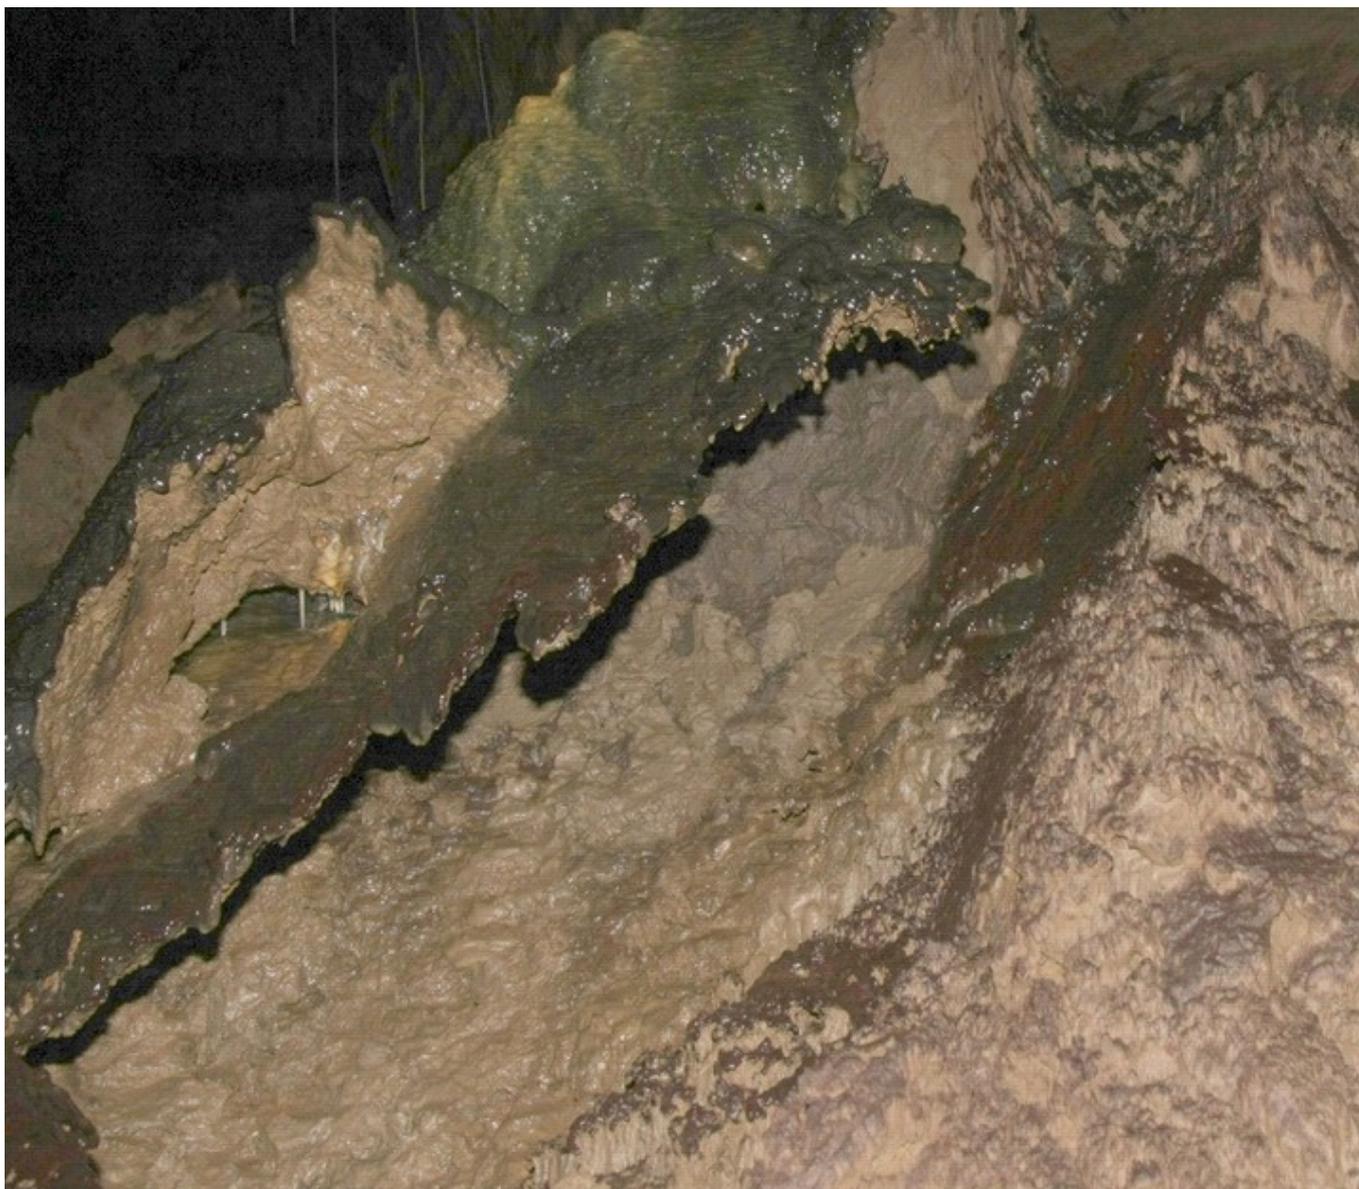
Green stained calcite over eroded sediment at Location 11:

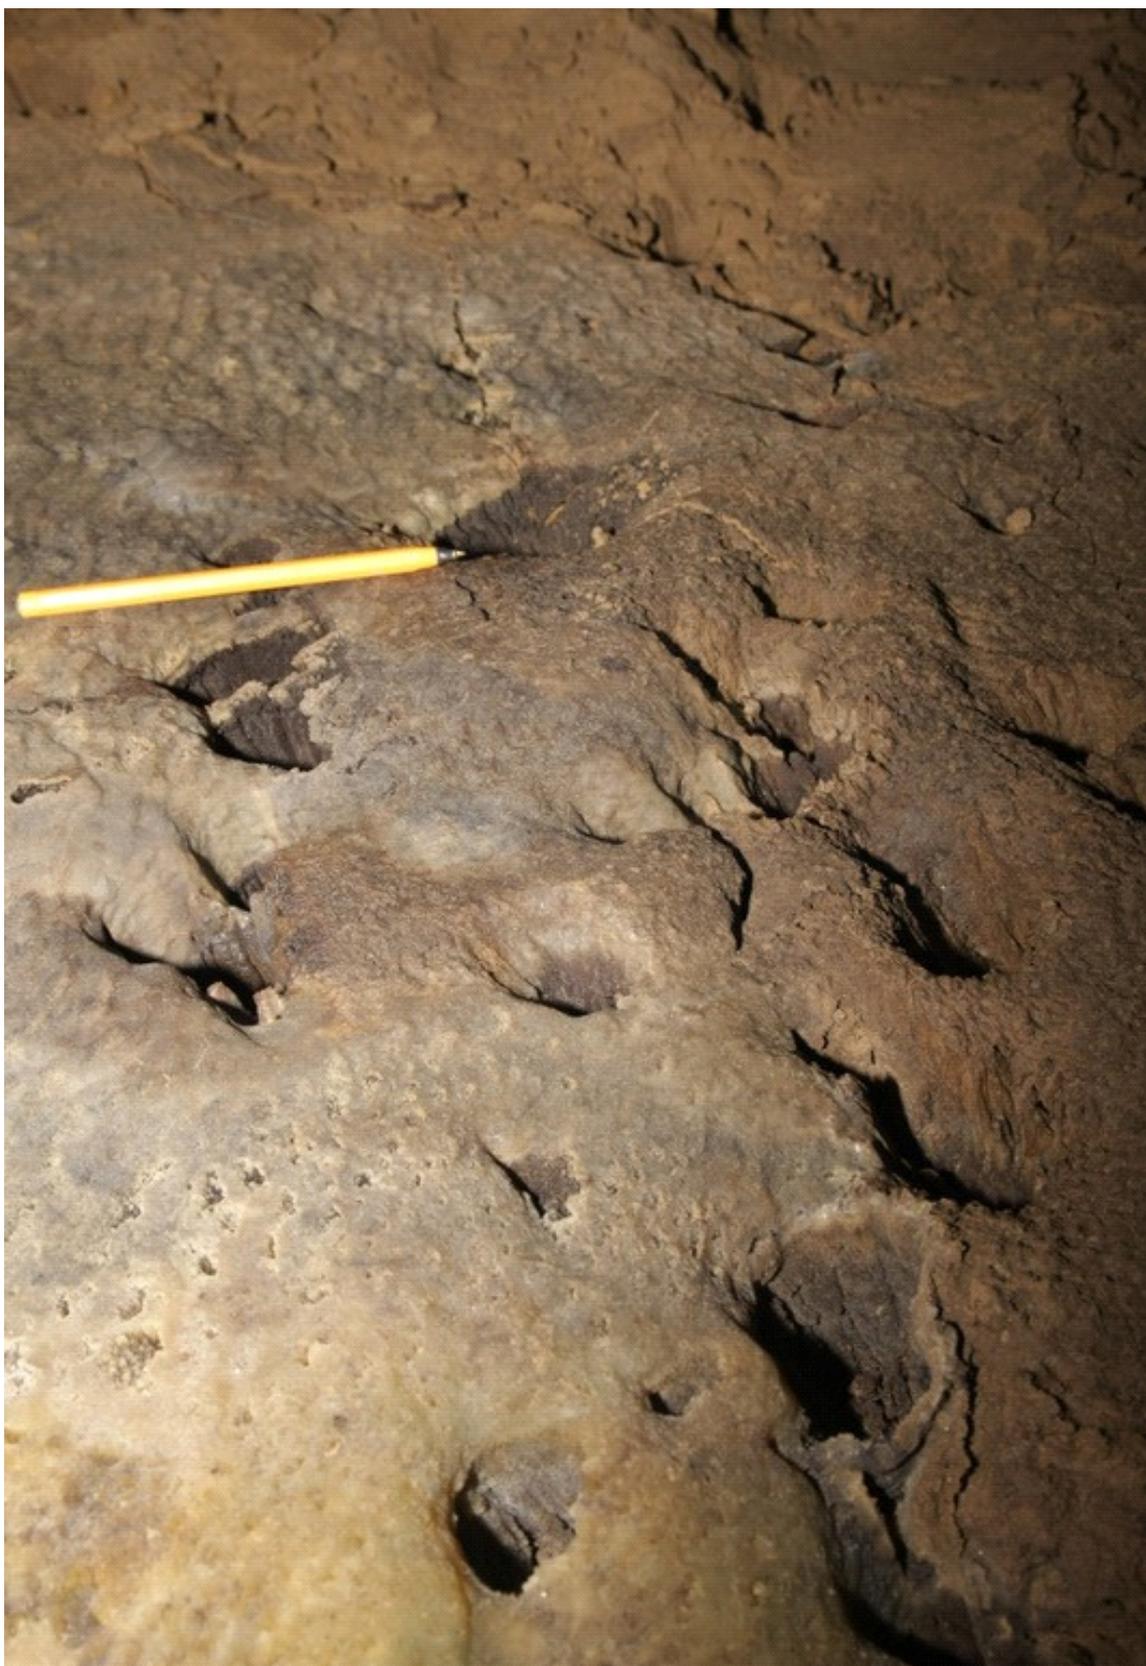
14. Also on the left in this section of passage is an area of calcite flow covering a sediment bank which contains some drip pits some 30 cm deep. The calcite flow spills into the pits implying that the pits pre-date the flow.

Drip holes with ball point pen for scale

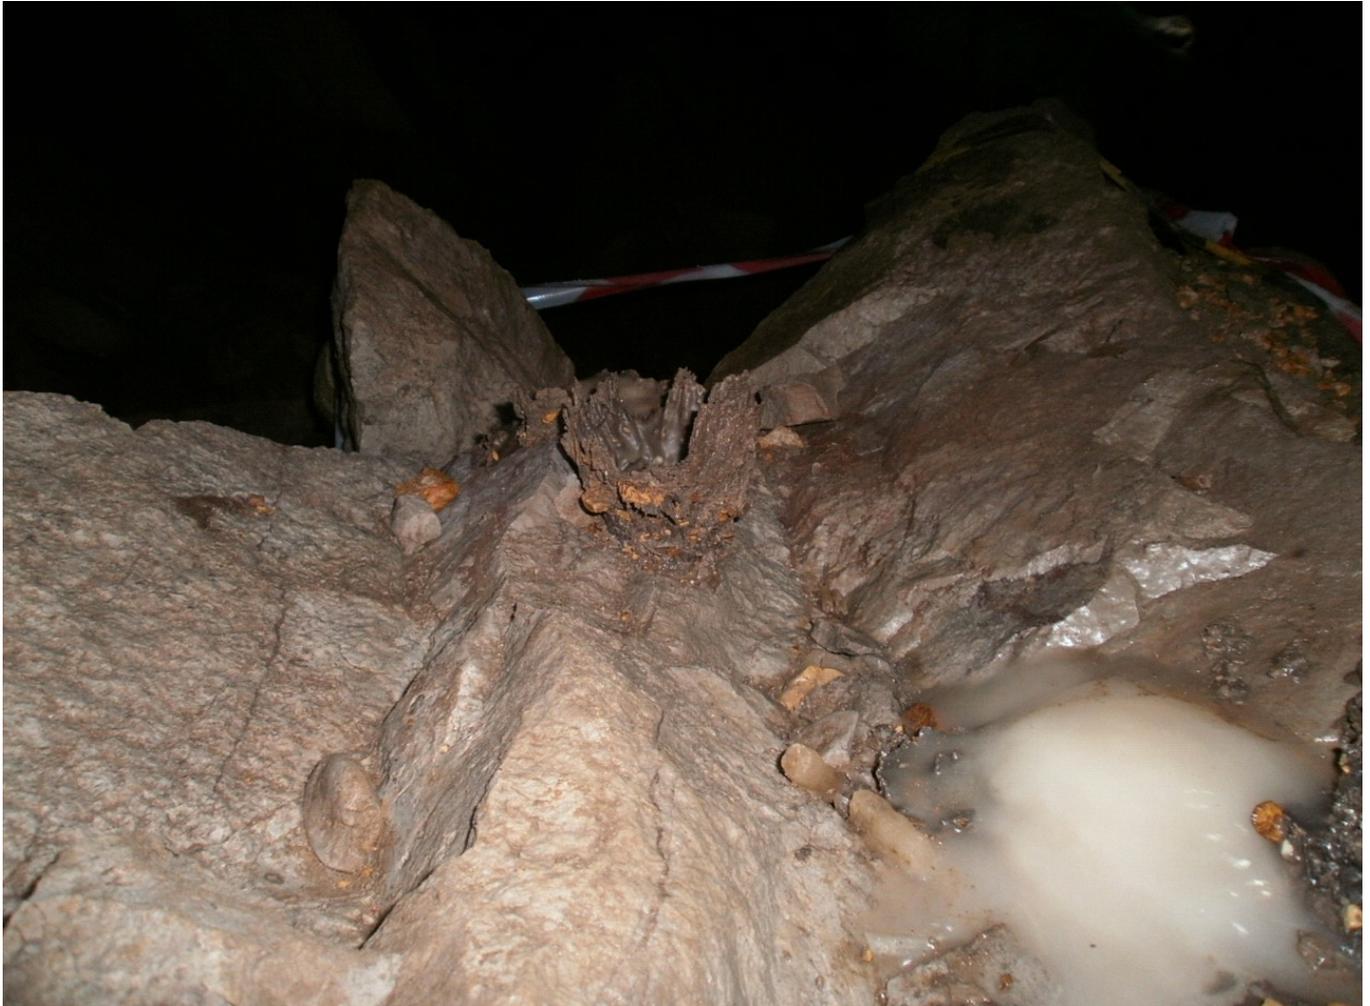
15. Clambering up through some fallen boulders leads into Dogger Bank Chamber. Jointing in the roof indicates that the fracture zone has been rejoined. This continues up Dogger Bank. At 2 m past the climb up is a 10 cm high calcite mould of a sediment drip pit left standing proud on a boulder to the left

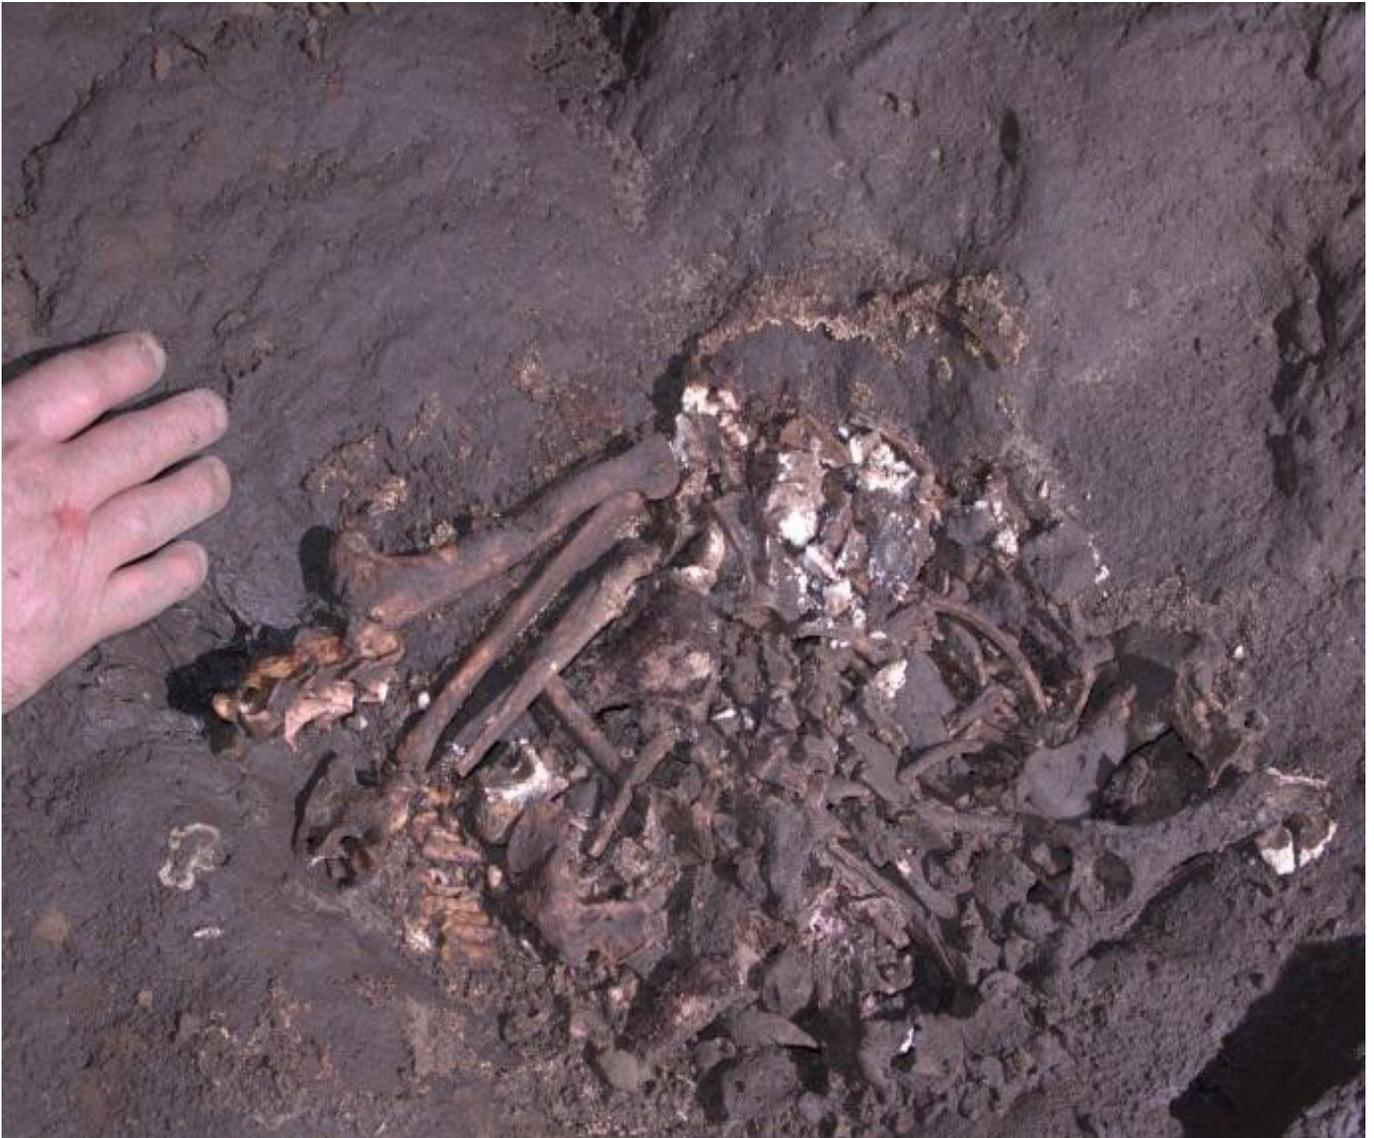
- 16.** A climb up the Dogger Bank sediment to the left leads to a small depression containing the skeleton of a dog. This has seriously deteriorated since it was first discovered as a result of excessive handling. It is not known how the dog entered the system, but when the skeleton was first seen it was clear that it must have been alive when it entered the chamber.

The dog skeleton has deteriorated dramatically due to unnecessary handling.

14	Calcite drip pits	5	
15	Calcite drip pit on fallen boulder	5	Very close to path
16	Dog skeleton	2	Barely recognisable heap of dust and fragments. Too much handling.
17	Calcited mud formations and cracked mud floor	4	A few footprints have appeared on the floor formations. Further taping undertaken July 2011.
18	Shale band in roof	5	
19	4m high varved sediment bank	5	Vulnerable to erosion at base despite taping
20	Forest of 2m long straws	5	Floor formations adjacent to straws vulnerable to photographers and models footprints. Well taped.
21	False floors	5	well out of reach
22	Oxbow—well decorated	5	taped out of bounds
23	Multiple avens	5

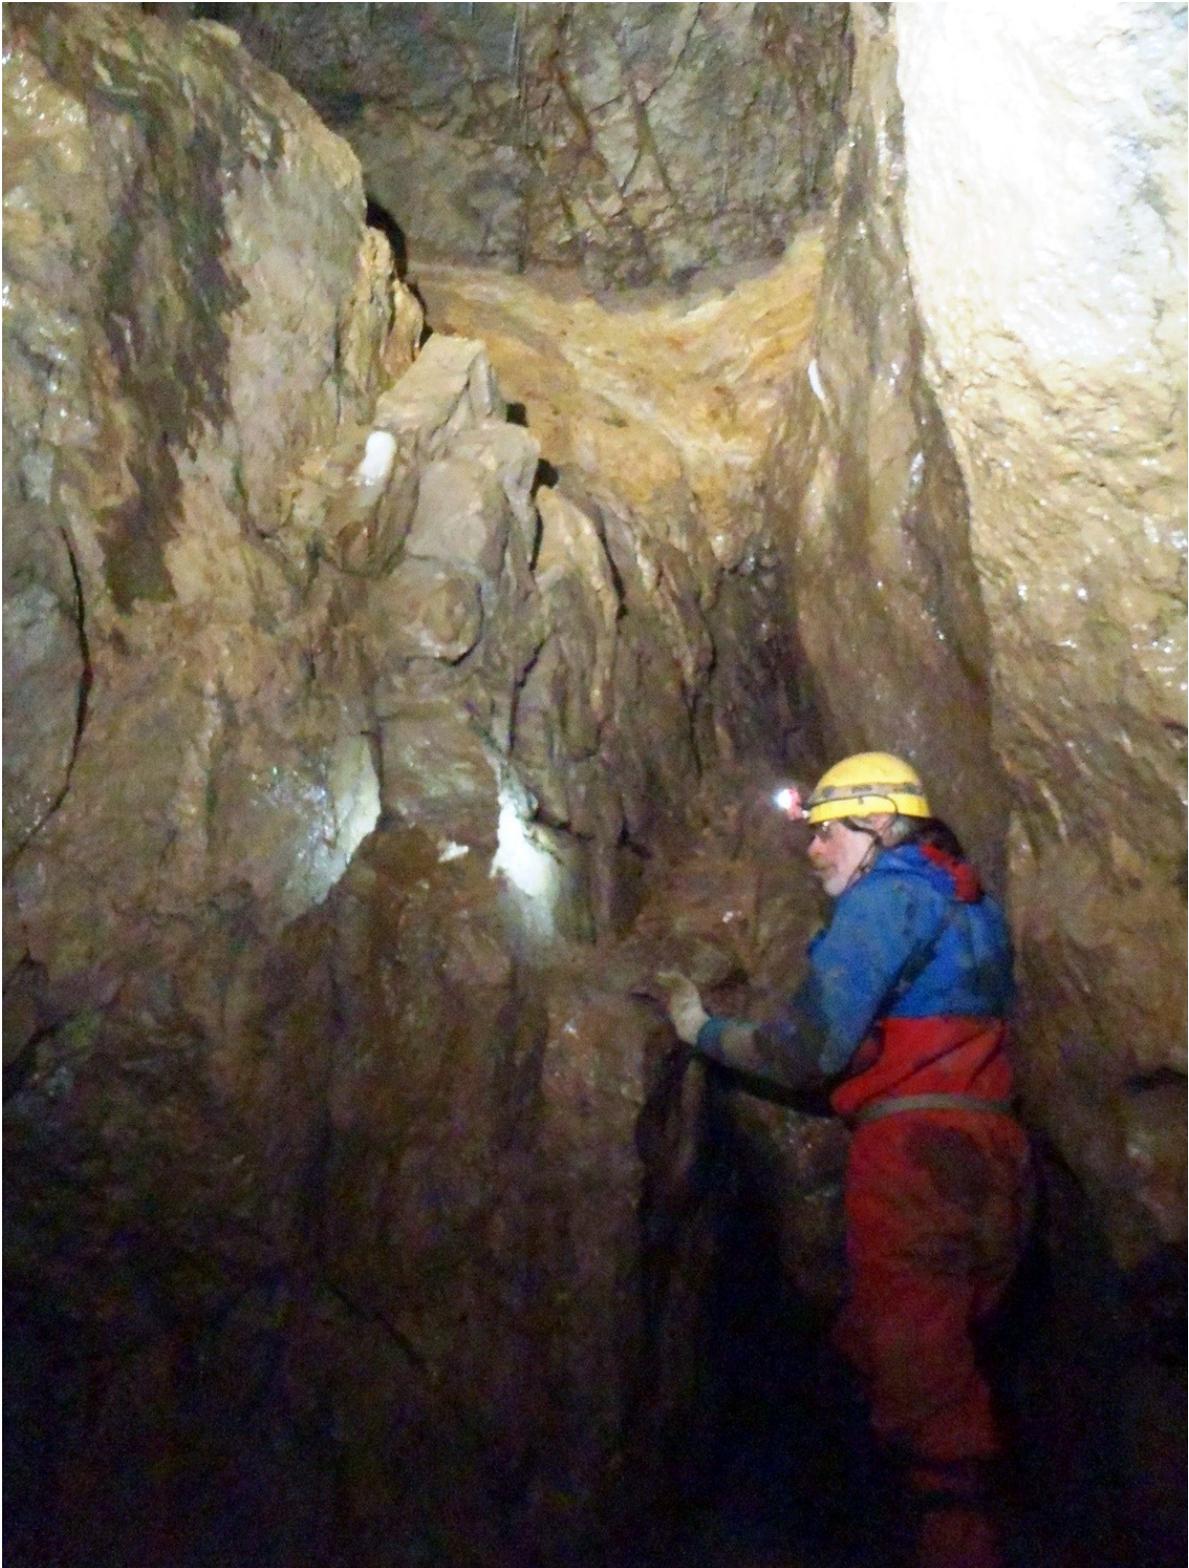
18. The passage terminates in a blank wall, with a possible way on being blocked by sediment. At roof level there is a 1m thick shale band. This shale bed is not seen elsewhere in the system, and is interpreted as a sequence boundary which was subjected to sub-aerial erosion. A gully formed in the paleokarst was then in-filled with sediment - probably volcanic ash.
