Witches Cave and Shuttleworth Pot

A Cave Conservation Plan Final Draft March 2012

Compiled by
Council of Northern Caving Clubs
with Natural England

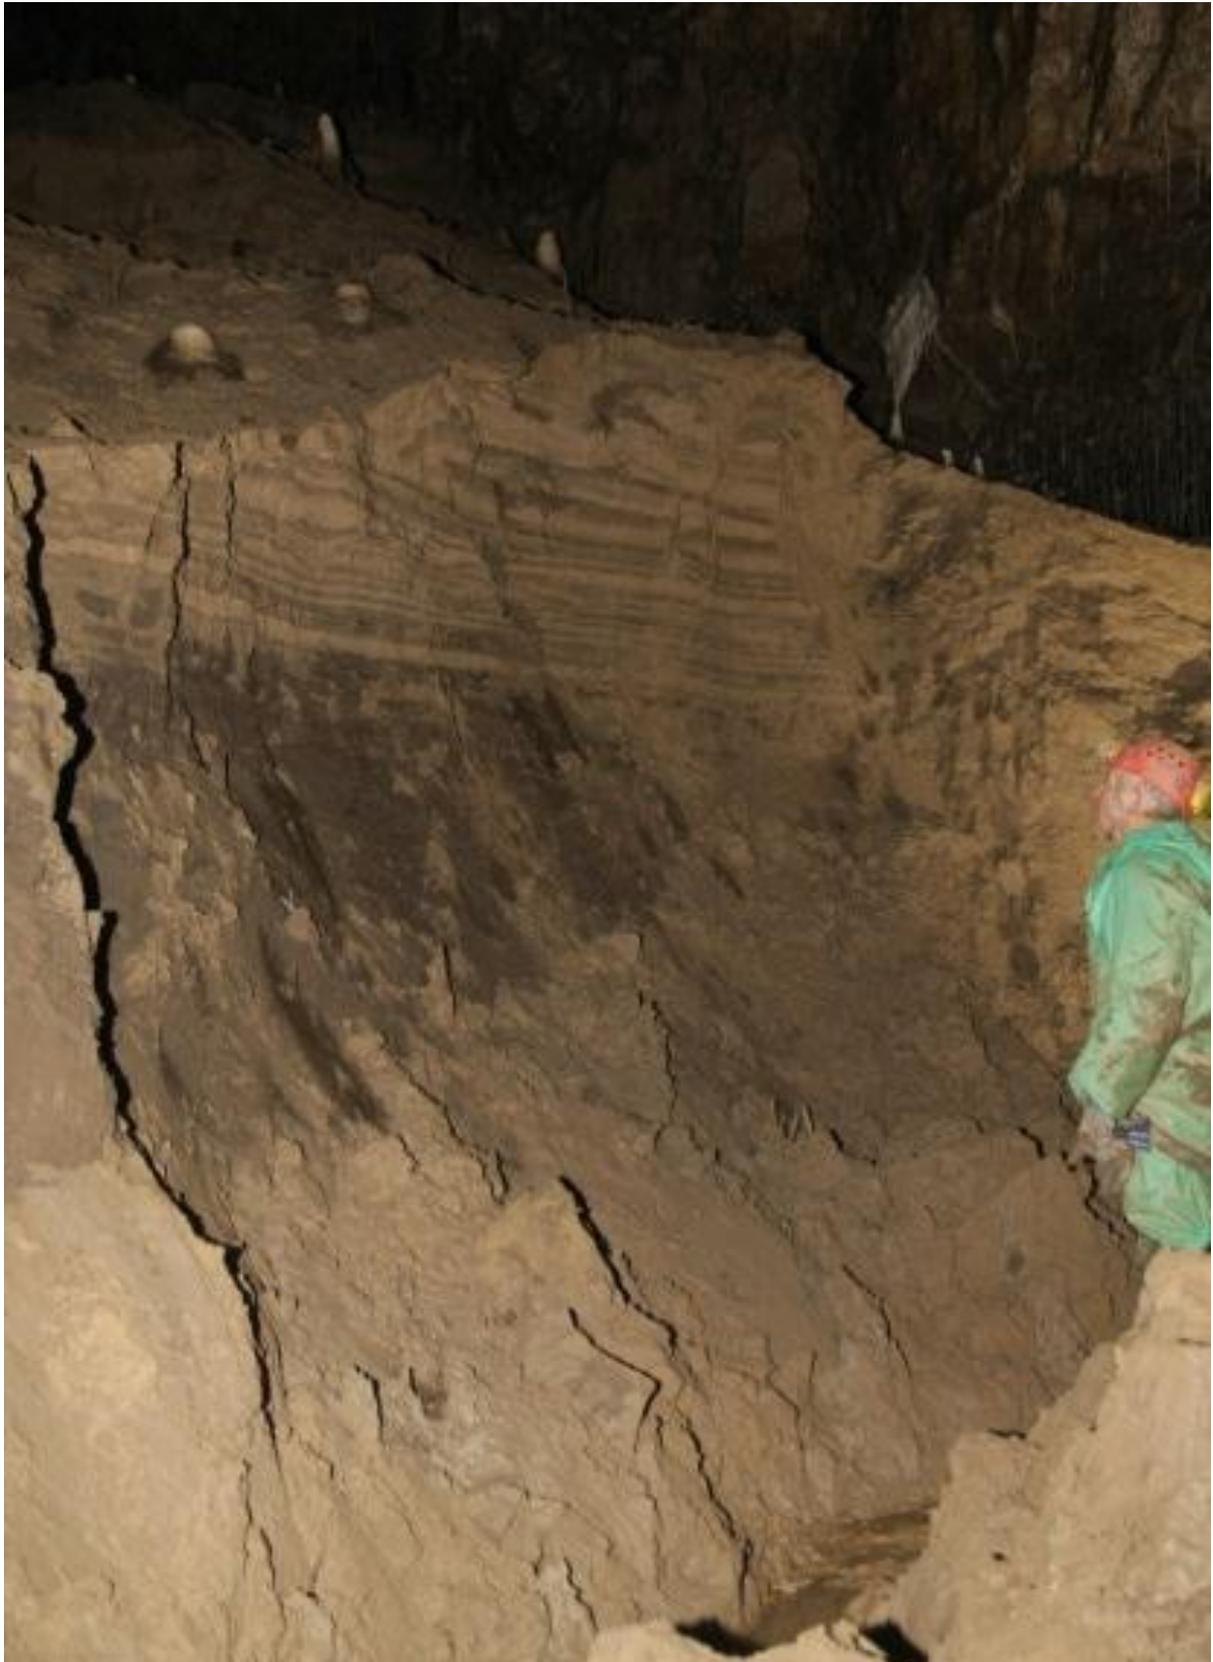
19. At the bottom of the Dogger Bank the stream enters from the passage straight ahead, where it has incised the Dogger Bank sediment to a depth of 4 metres exposing a fine section of varved sands and clays. The base of the sediment has many mud-drip formations.

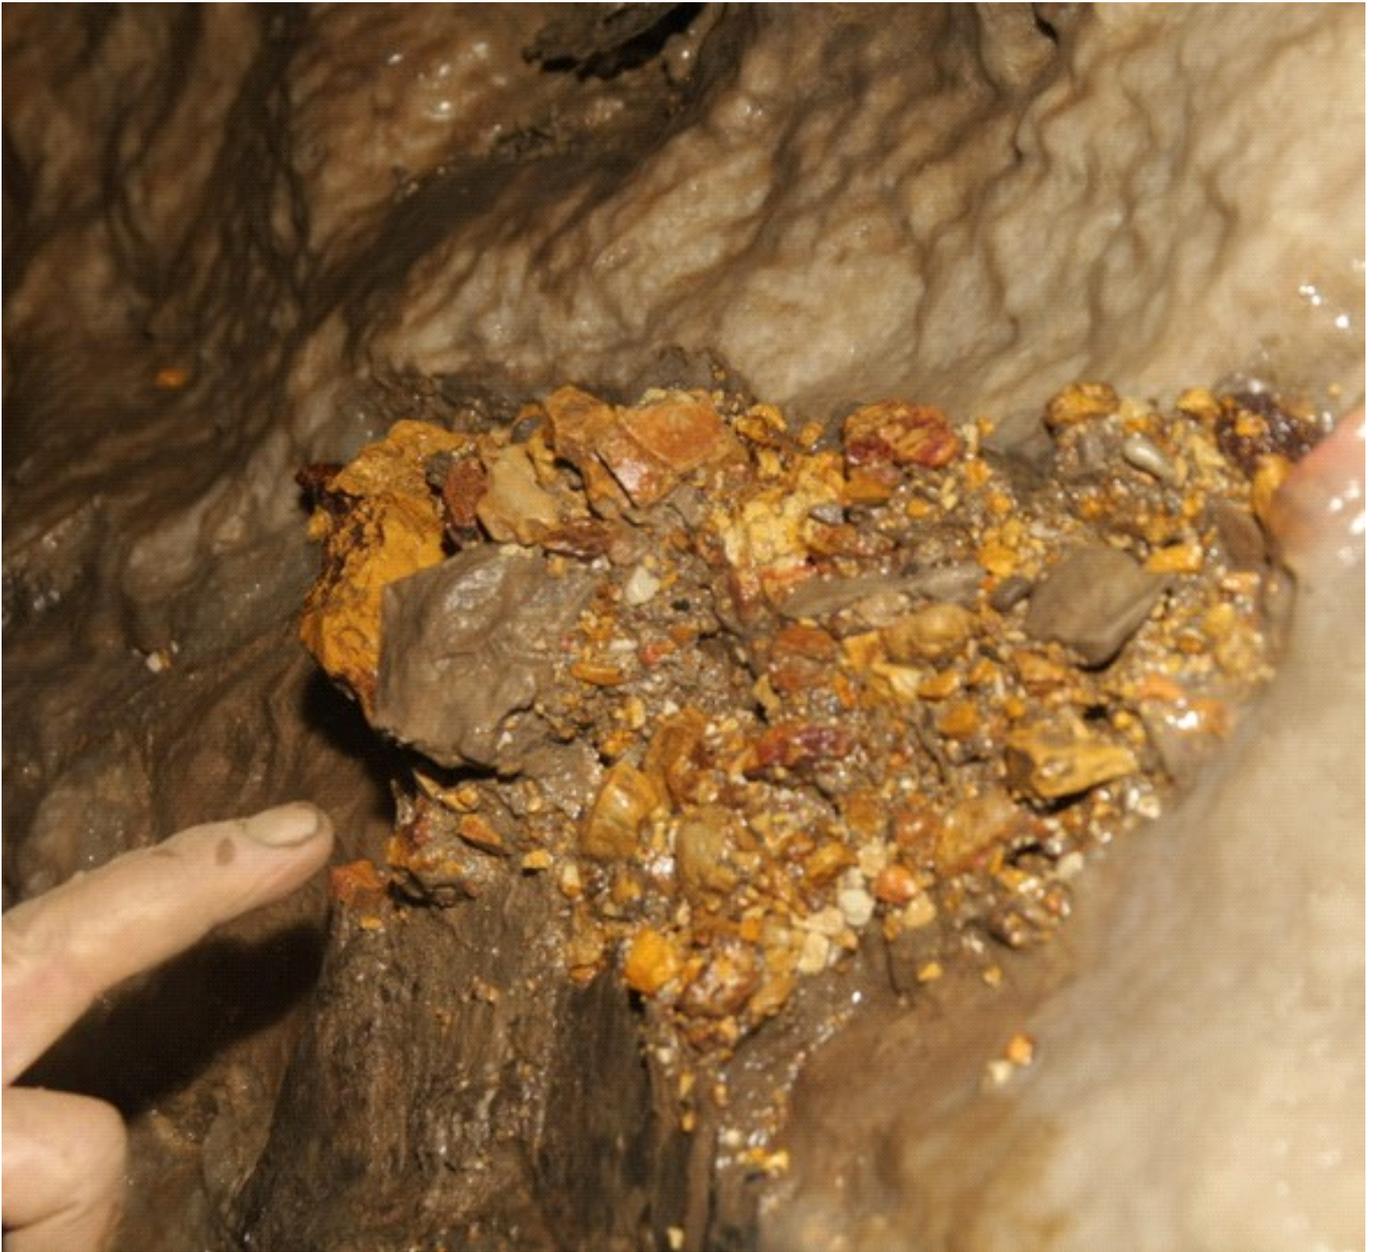
Gravel deposits resting on calcite resulting from fluvial re-invasion of the passage at Location 21:

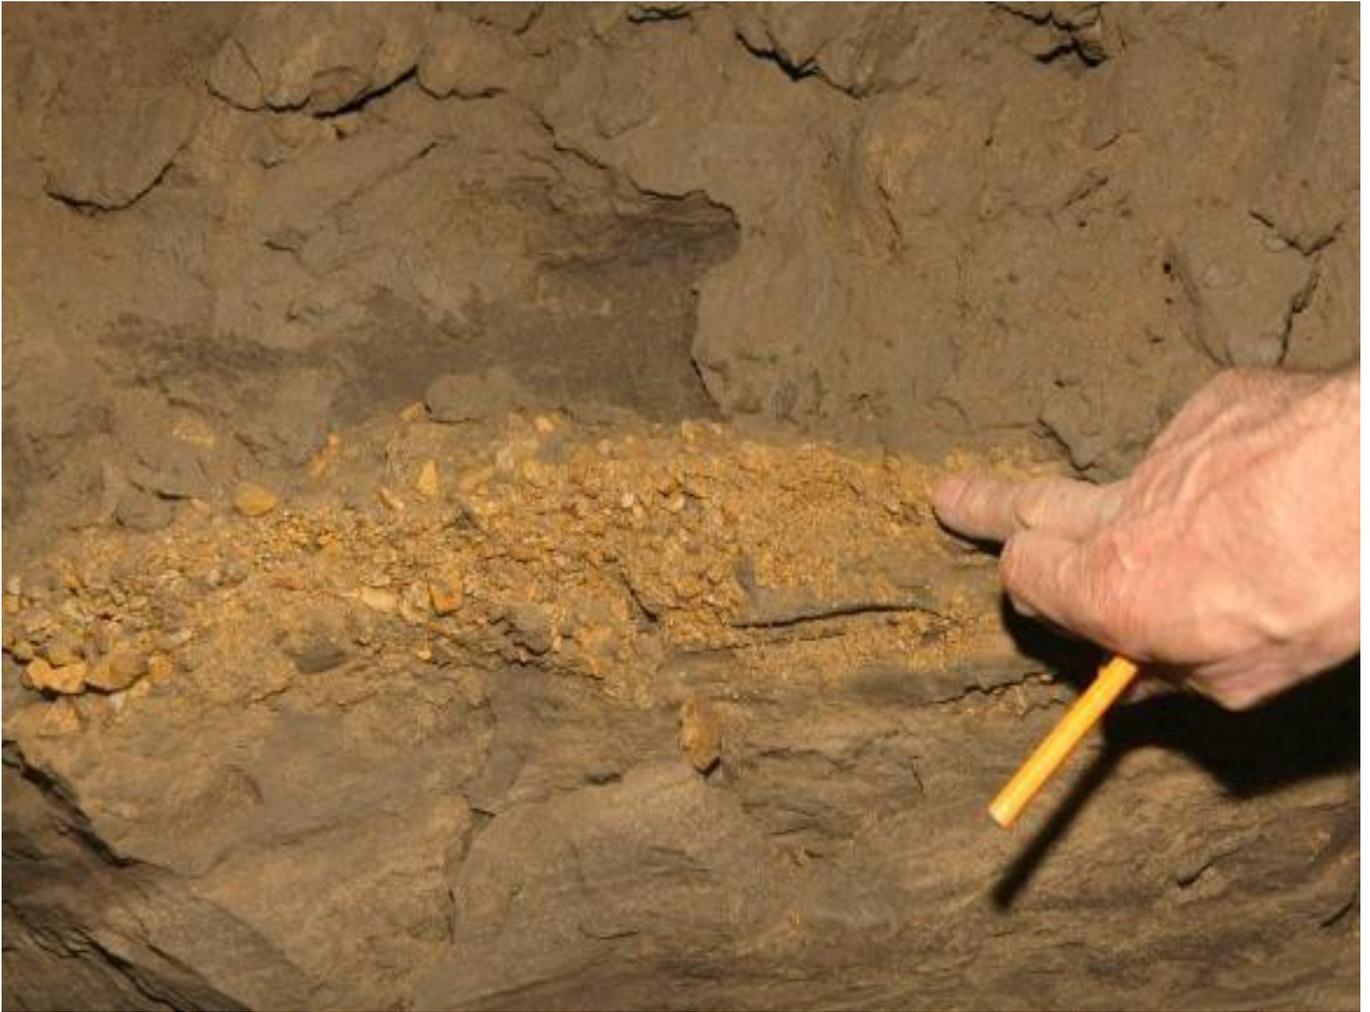
Gravel deposits at Location 21:

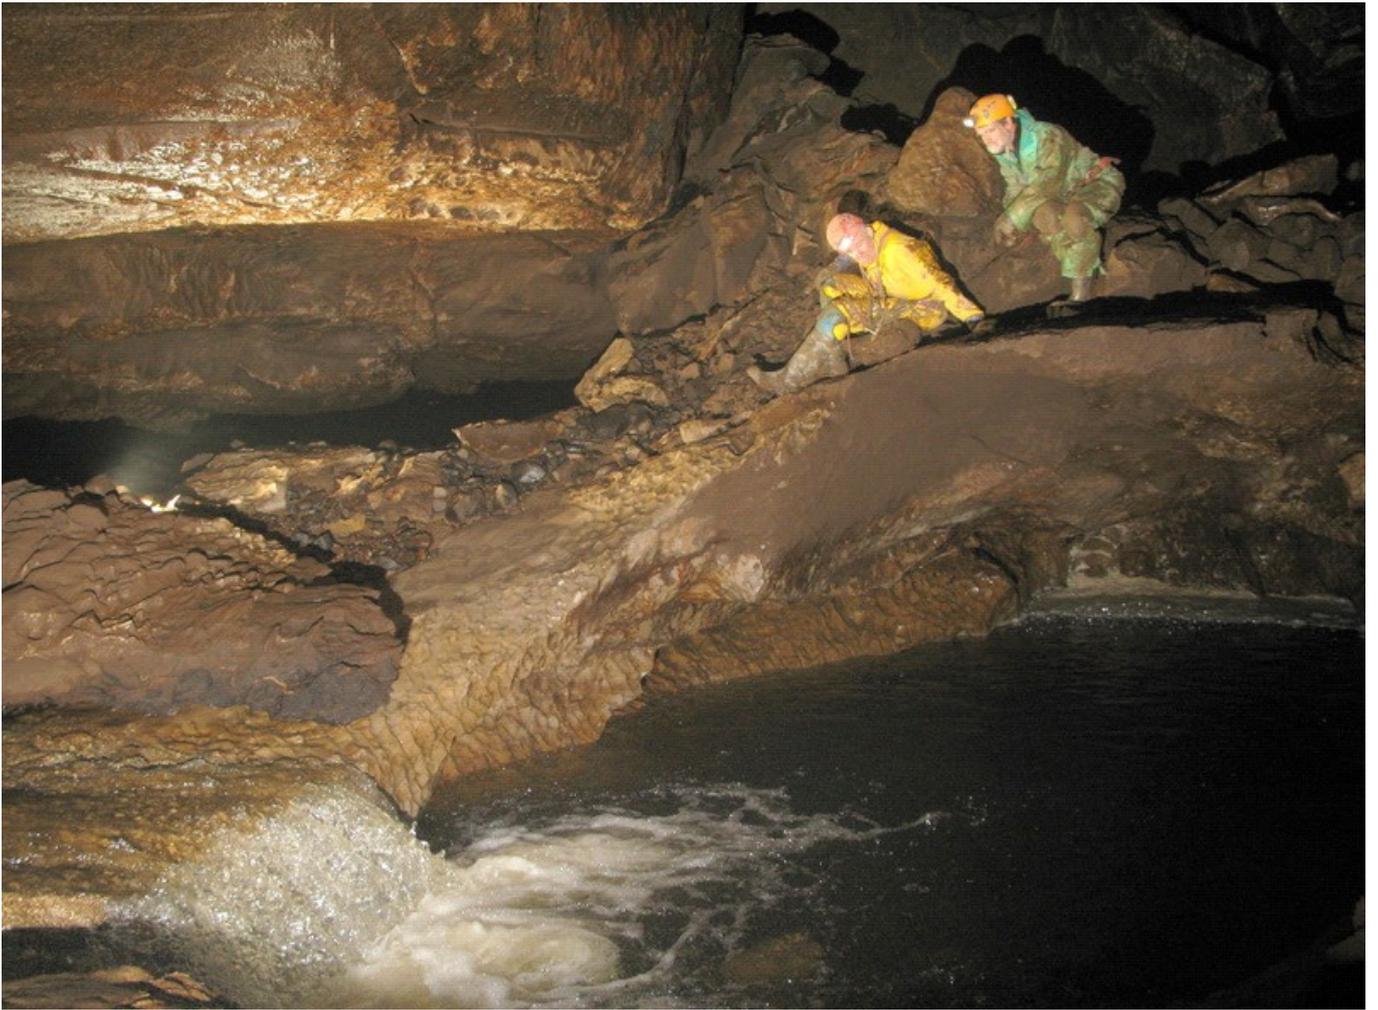
The House of the Rising Sump in Low flow conditions

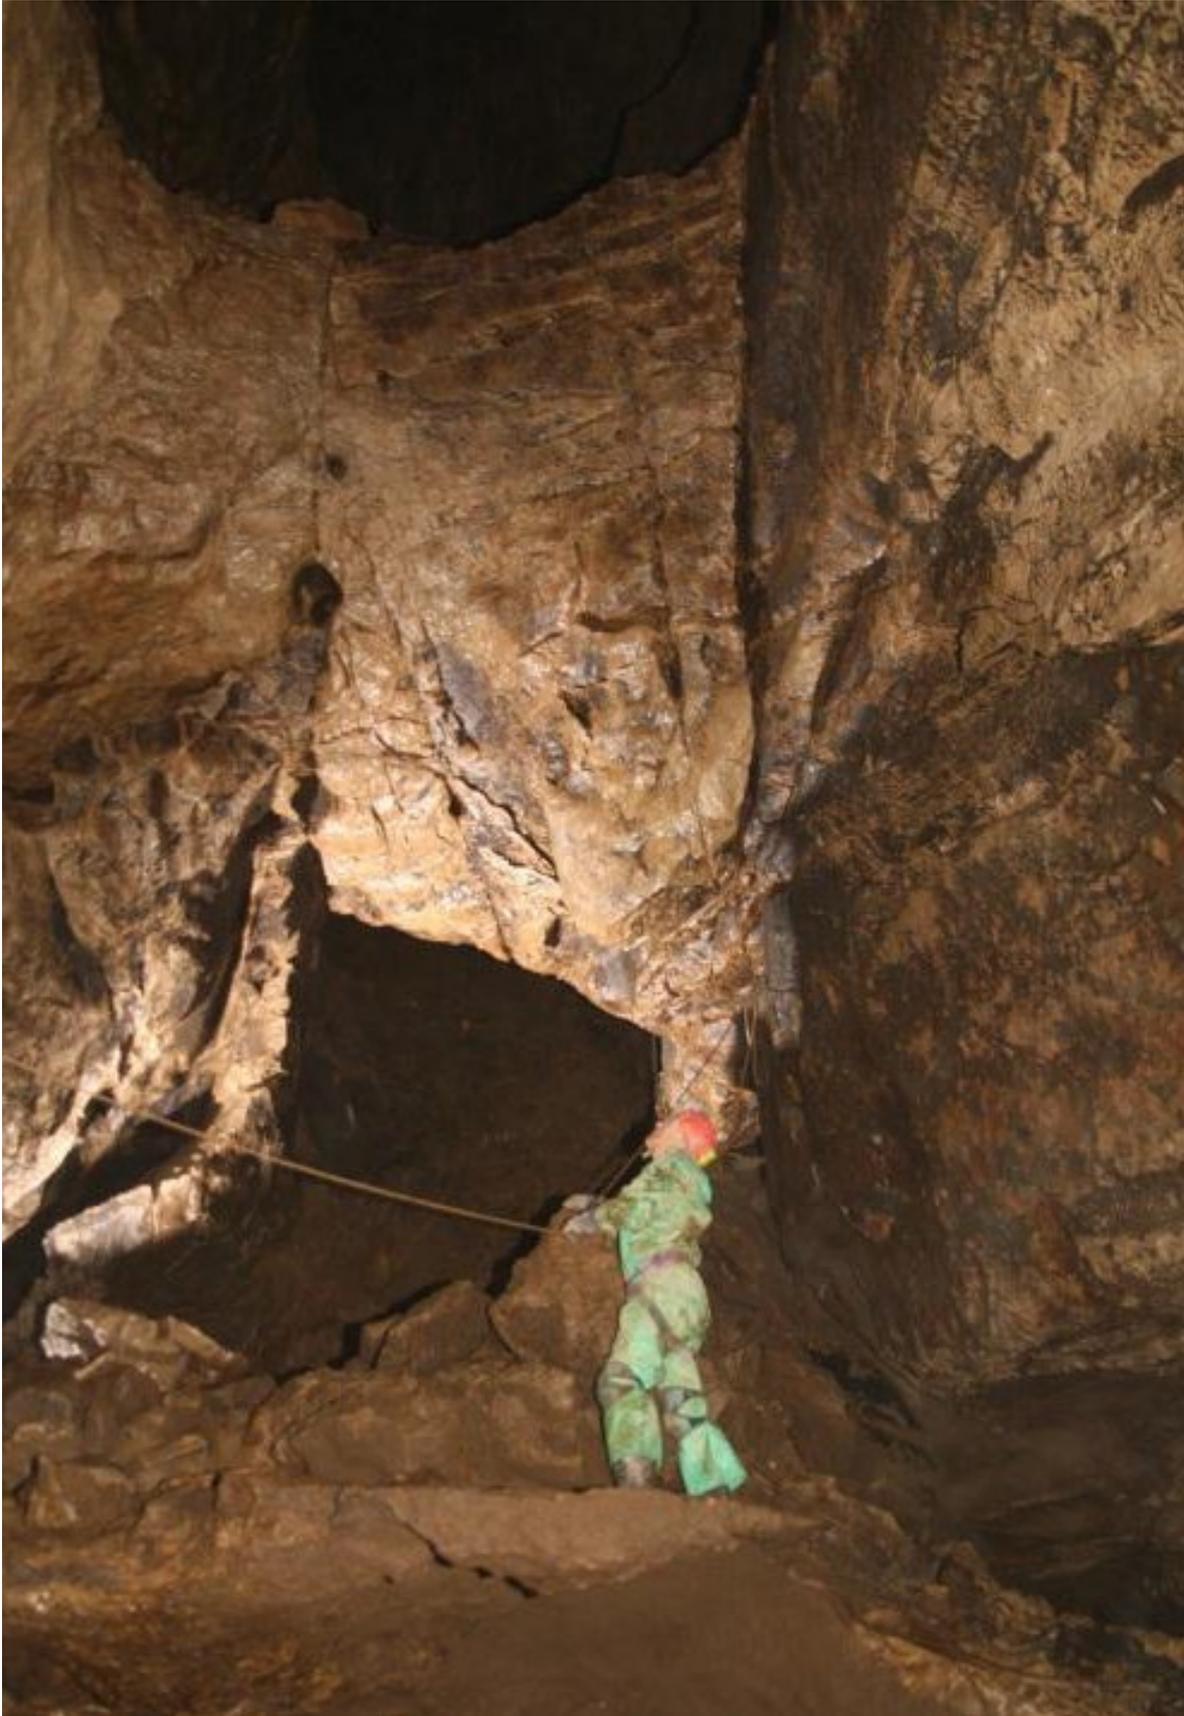
27. In the roof towards the south the fragment of floor from the main passage which connected the base of Diver's Pitch to the Exercise Yard can be seen to be associated with the fracture zone.

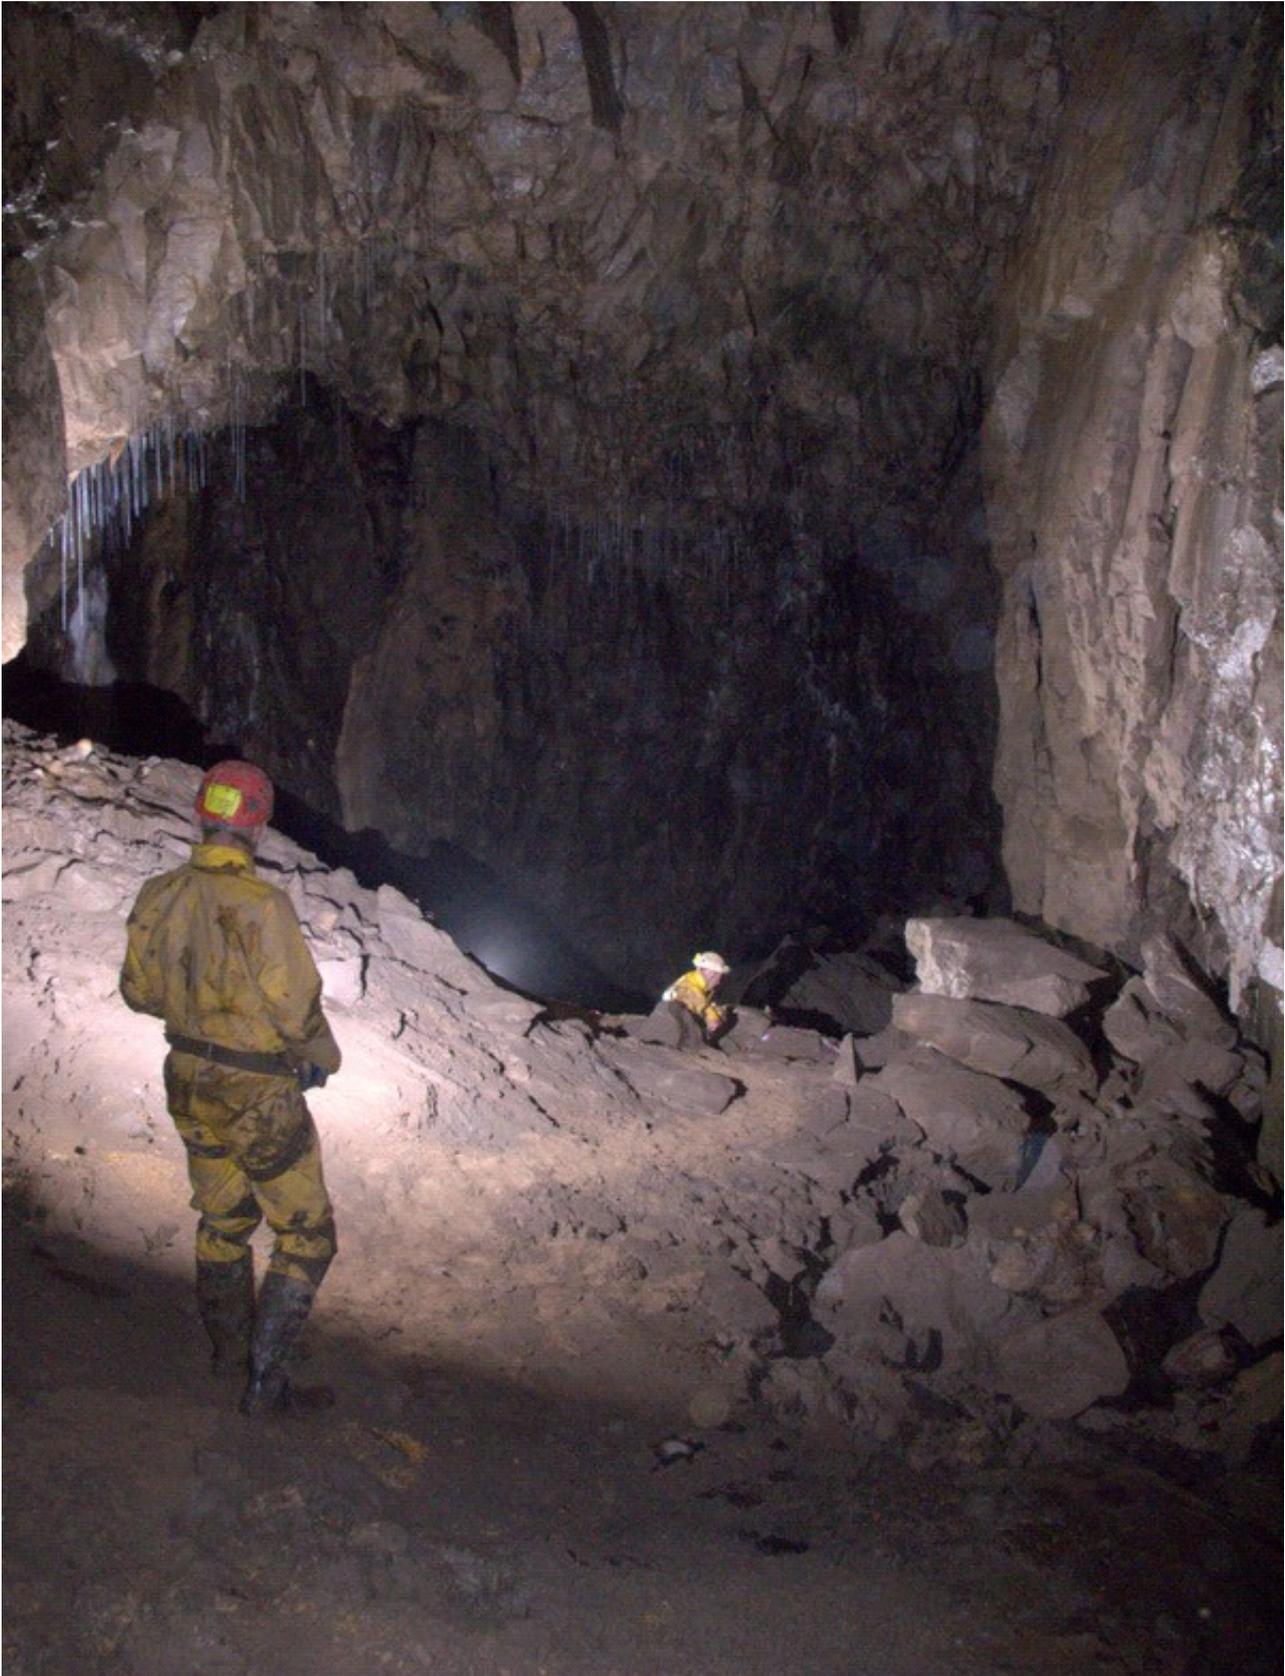
28. A steep ramp then rises towards the north to the Exercise Yard, following the line of the fracture zone. A small inlet trickles down this, actively depositing calcite.

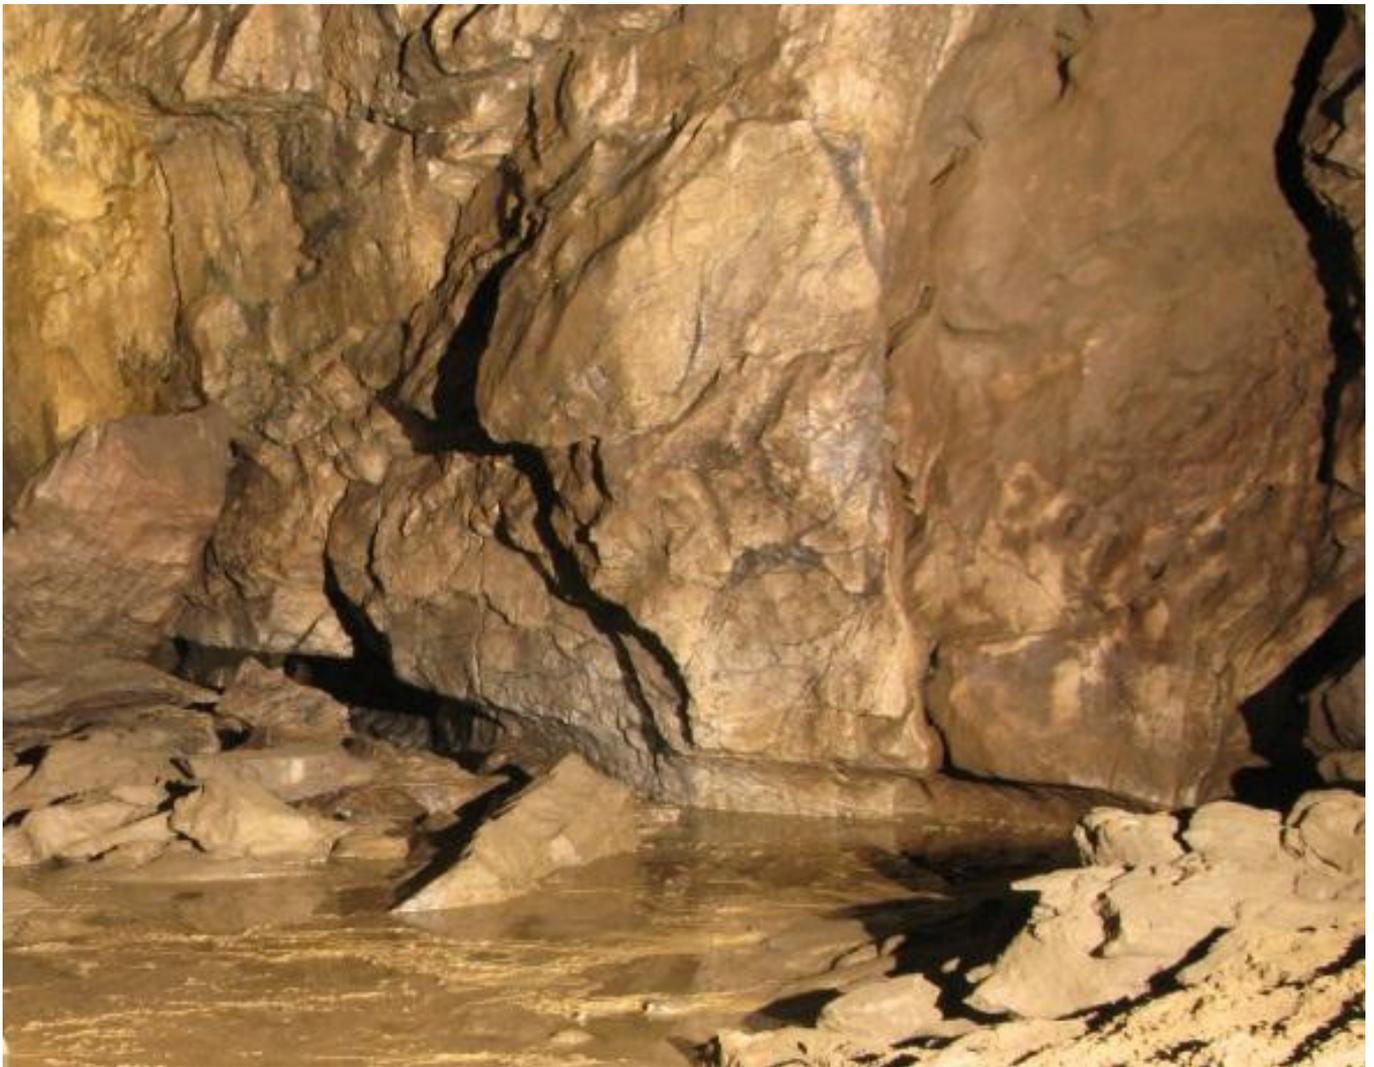
29. At the top of the ramp, is the Exercise Yard – an impressive section of 10 m wide, 15 m high passage, initially floored with boulders. There is a distinct notch 30 cm high in the base of the left-hand wall which continues over the ramp for another 20 m.

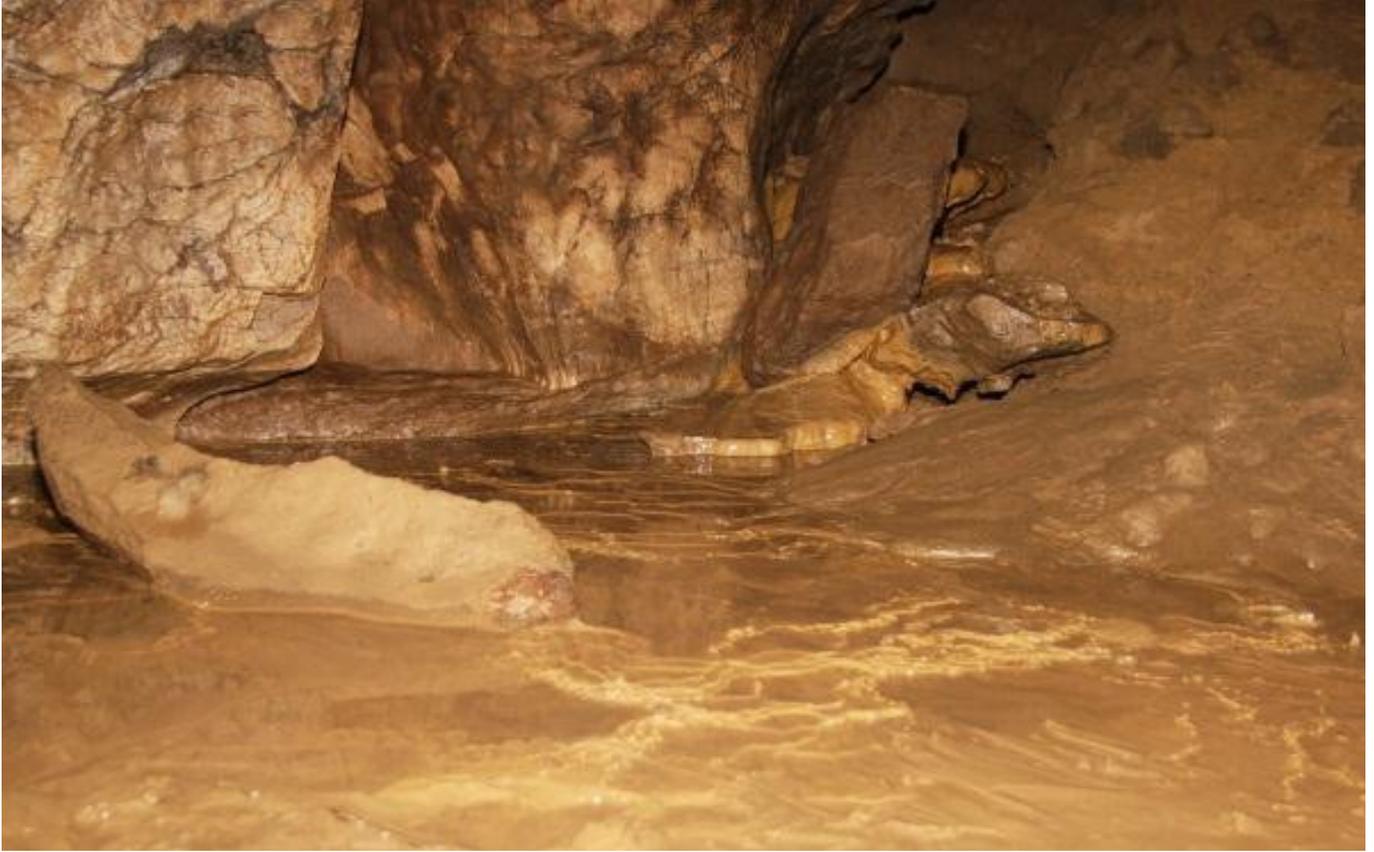
30. Mud banks start to appear beyond Zig-Zag passage, which goes off to the right. Opposite Zig-Zag passage is an area of shallow gour pools and calcite floor, fed from a small inlet. Large 30 cm flow markings a little beyond the entrance to Zig-Zag passage indicate a flow to the north.

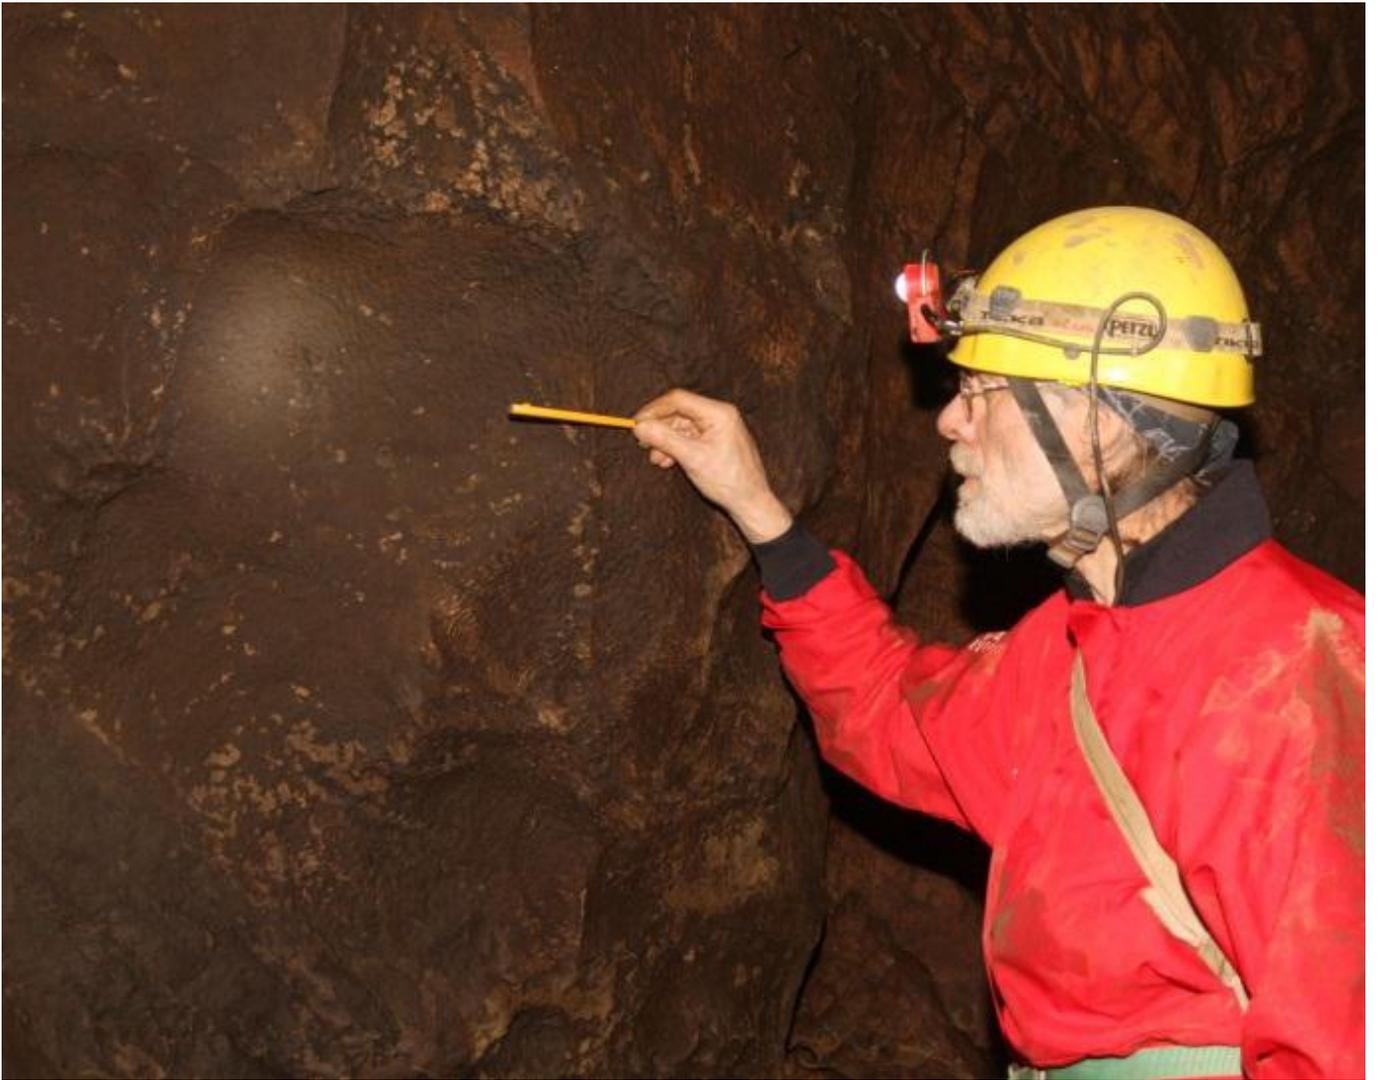
Large Flow markings to the north of the Zig- Zag Passage entrance

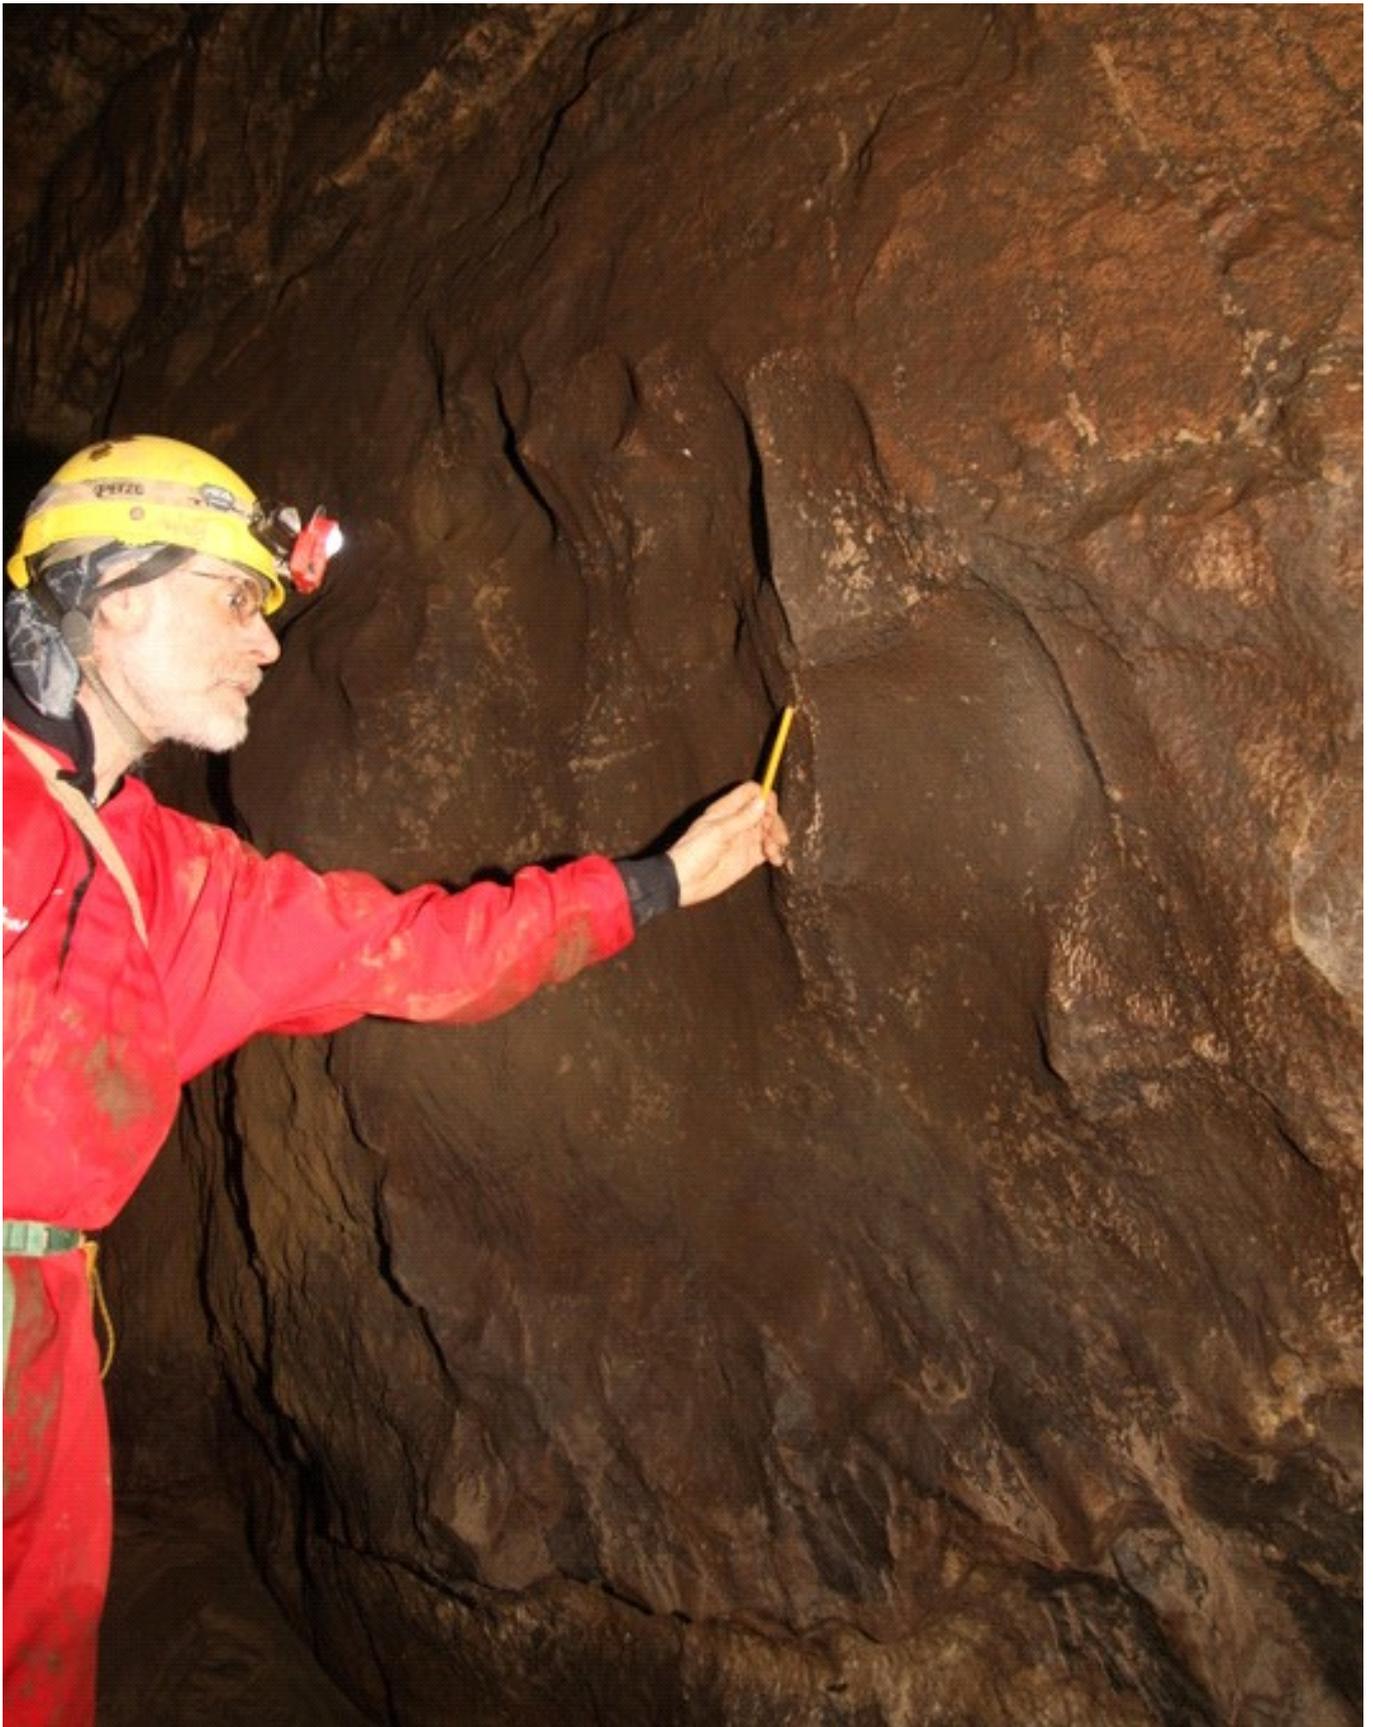
Flow markings near the entrance to Zig-Zag Passage:

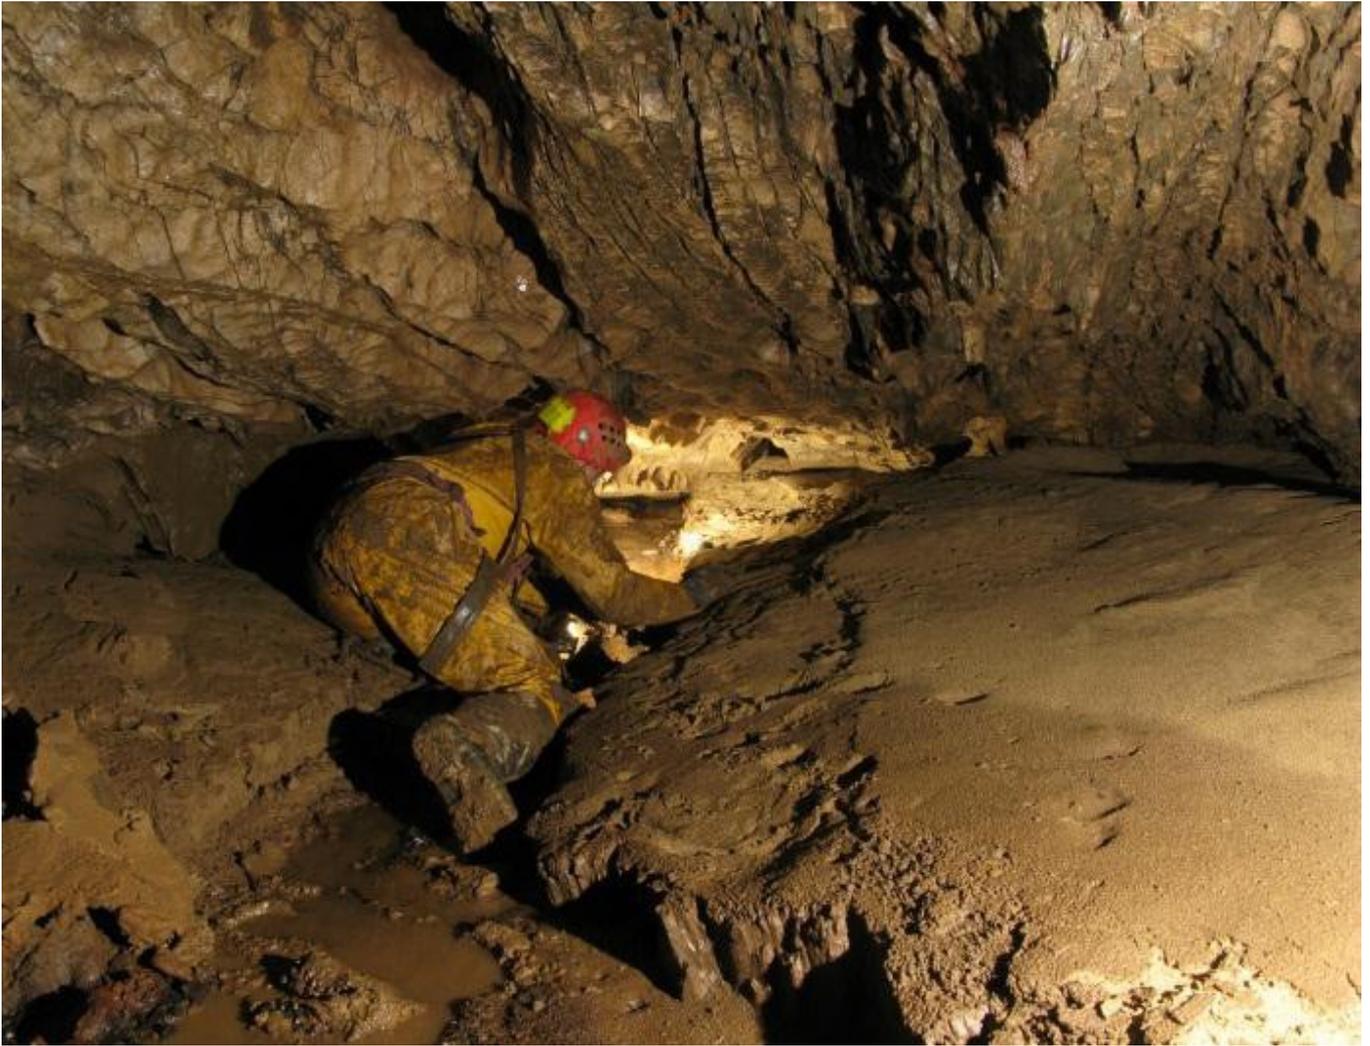
31. The main passage finishes in a wall, with a low passage filled with soft sediment at floor level.

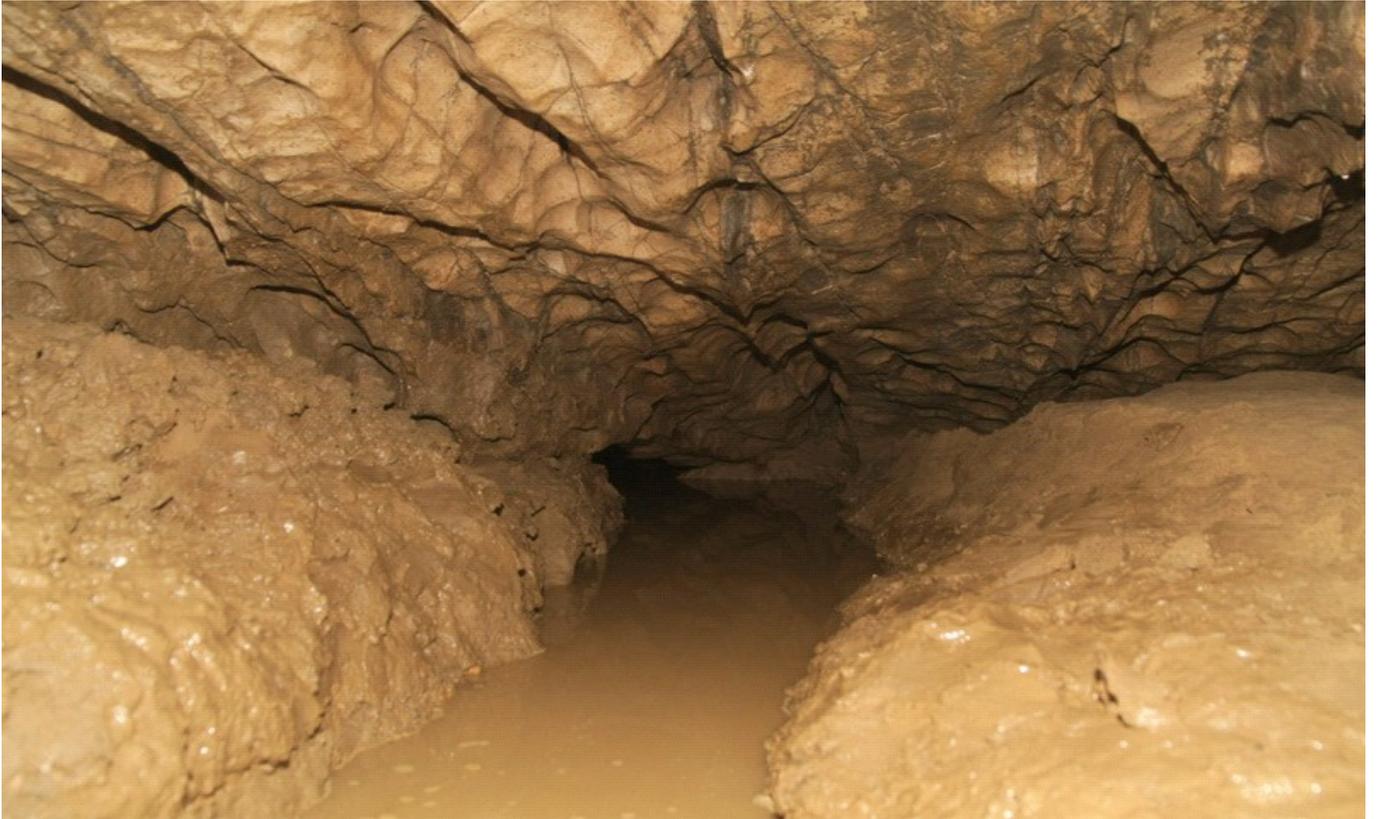
The mud choke at the end of the Exercise Yard:

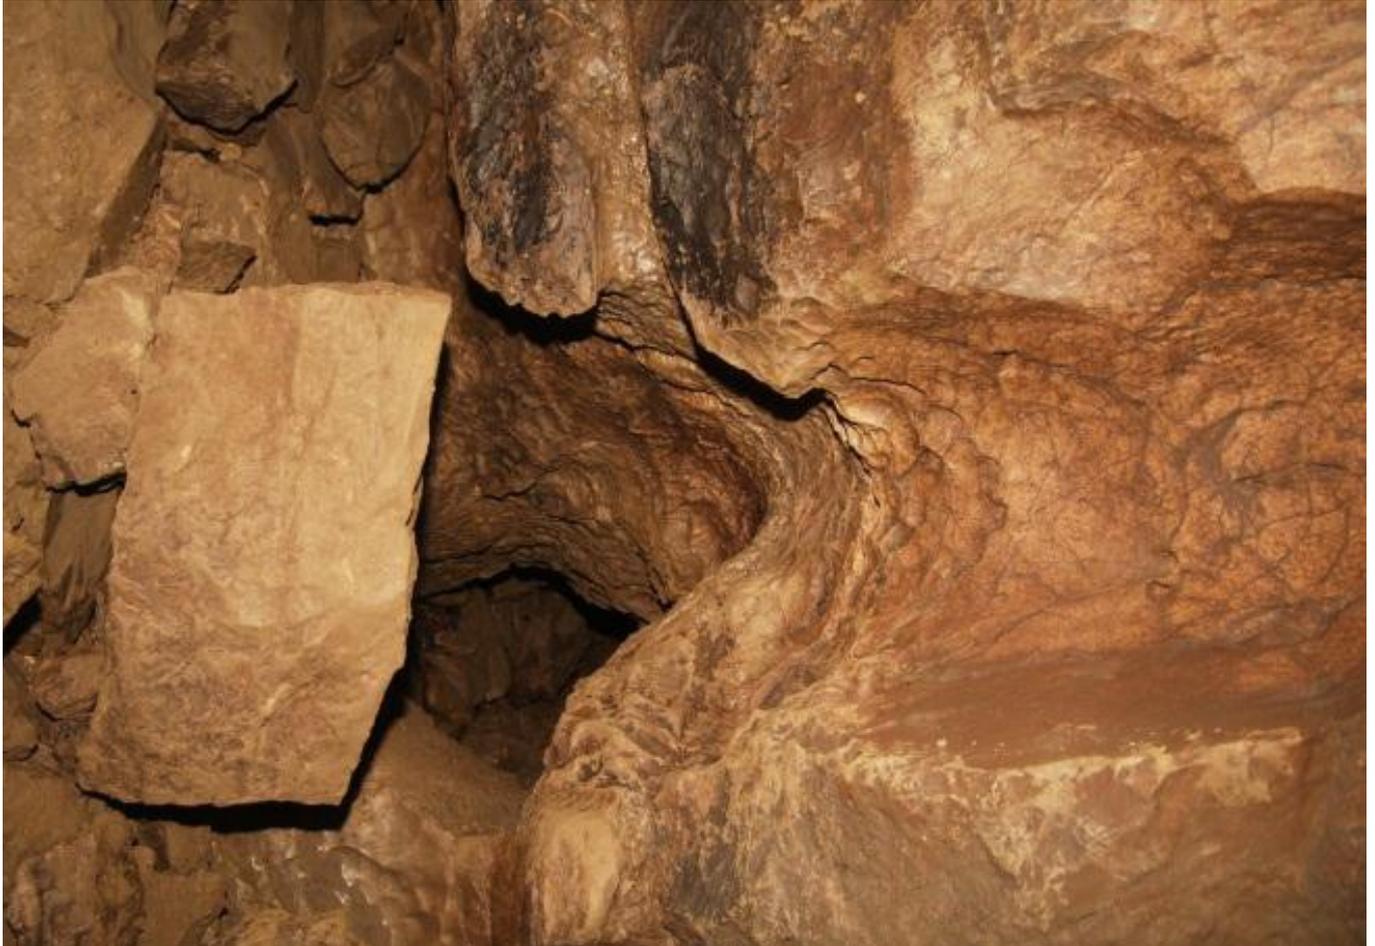
32. Zig-Zag Passage is a descending 'joint-controlled' passage with flow-markings showing a flow outwards, indicating that this seems to have been a phreatic flood-rising from the lower sump passages. This rising may be associated with the notch in the base of the main passage wall, and explains the lack of sediment banks below the entrance to Zig-Zag Passage. The first 2 m of Zig-Zag Passage have many micro-joints with raised mineral veins.

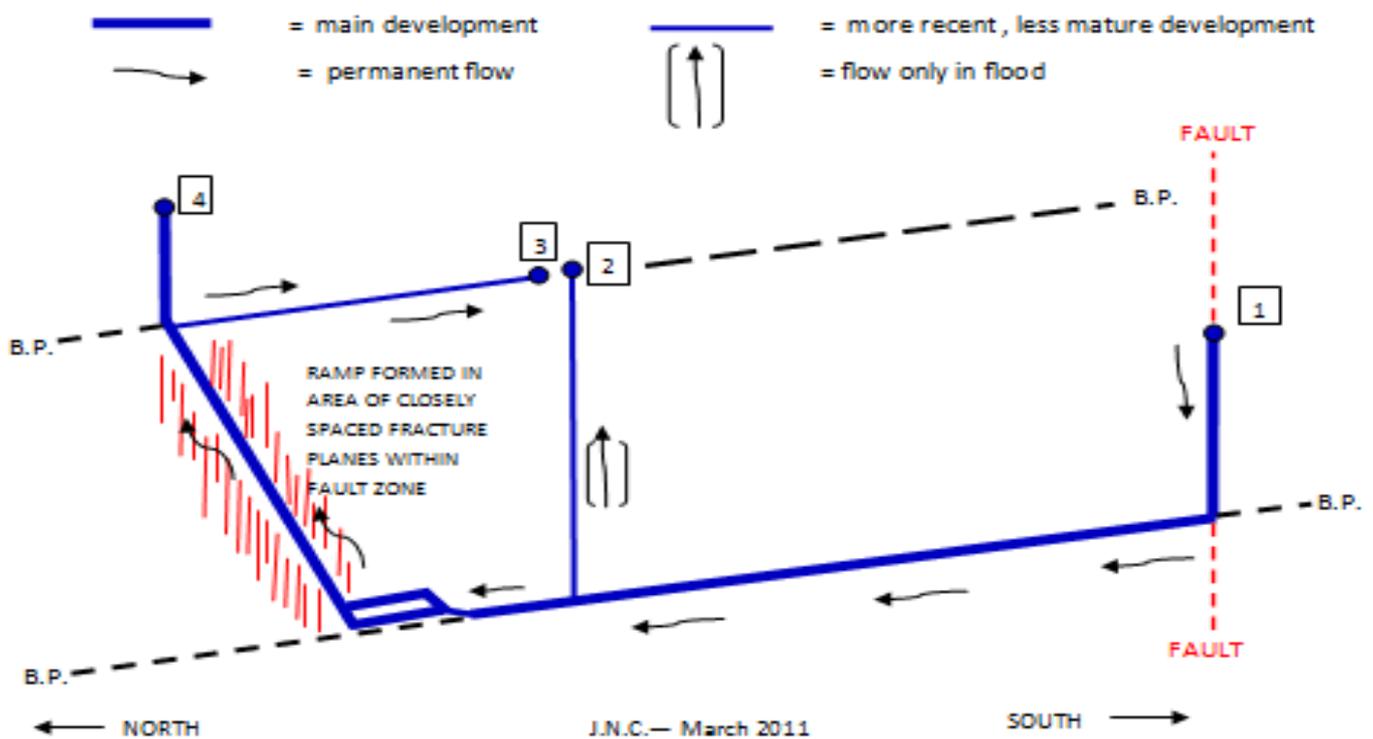
Extended diagrammatic elevation along 550 m sump from Witches Cave dry extension to Leck Beck Head (not to scale)
